General Information

Make	Toyota	Model	Vios
YOM	2021	Odo Meter Reading	59,742
Registration No.	DBF3016	Chassis No.	PA1B18F33M4158311
CC	1.3	Transmission	CVT
Fuel Type	Gas	Type of Body	Sedan
Colour	Black

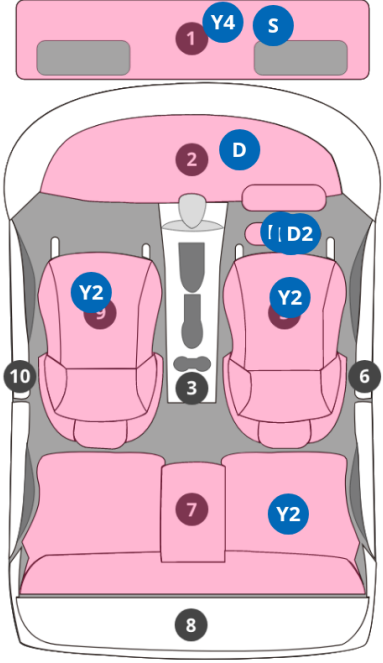
Interior Evaluation : C	Exterior Evaluation : E

<p>a : Cut, Fray d : Loose, Deformed k : Animal Hair s : Smell t : Cigarette Burns x : Defective y : Stain</p>

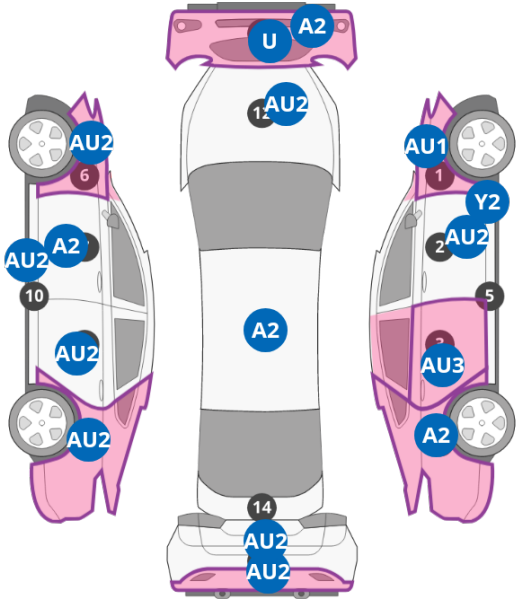
<p>A : Scratch AU : Scratch & Dent B : Modified C : Corrosion G : Stone chip P : Faded S : Rust SC : Rust & Corrosion U : Dent X : Defective Y : Crack, Gap</p>
<p>Remarks Overall Interior - Smell - Yes / Rear Seat - Grime - Small / (R) Front Seat - Grime - Small / (L) Front Seat - Grime - Small / Dashboard - Traces of Adhesive Tape - Yes / Ceiling - Grime - Large / (L) Front Floor Mat - Worked - Large / (R) Front Floor Mat - Worked - Small / Mat Other - Worked - Small</p>	<p>Remarks (R) Rear Door, Molding - Repair mark - Yes / (R) Rear Fender, Molding - Repair mark - Yes / (R) Rear Fender, Molding - Scratch - Small / (R) Rear Door, Molding - Scratch & Dent - Medium / (R) Front Door, Molding - Scratch & Dent - Small / Rear Bumper, Lamps, Panels - Repair mark - Yes / Rear Bumper, Lamps, Panels - Scratch & Dent - Small / Trunk Hood, Rear Gate - Scratch & Dent - Small / (L) Rear Fender, Molding - Repair mark - Yes / (L) Rear Fender, Molding - Scratch & Dent - Small / (L) Rear Door, Molding - Scratch & Dent - Small / (L) Front Door, Molding - Scratch - Small / (L) Front Fender, Molding - Scratch & Dent - Small / Front Bumper, Grille, Lamps - Repair mark - Yes / (L) Front Fender, Molding - Repair mark - Yes / Member (Bolted) - Dent - Yes / Front Bumper, Grille, Lamps - Scratch - Small / Bonnet, Headlight - Scratch & Dent - Small / (R) Front Fender, Molding - Repair mark - Yes / (R) Front Fender, Molding - Scratch & Dent - Minimal / (R) Step, In-panel, Side Spoiler - Crack, Gap - Small / (L) Step, In-panel, Side Spoiler - Scratch & Dent - Small / Roof - Scratch - Small</p>

<p>Inspector Notes</p>
<p>With LTO plate and Sparetire and, Incomplete Tools. No Jack and Warranty booklet, possible flooded, Scratch headlight and tail light crack. Warning lamps on airbag, Tow hook cover missing, worn tires and Sparetire, rear bumper reflector missing, adhesive marks on wind shield and vehicle body,</p>
