General Information

Make	Toyota	Model	Veloz
YOM	2024	Odo Meter Reading	17,032
Registration No.	DBO7661	Chassis No.	MHFAB1BY7R3093929
CC	1.5	Transmission	CVT
Fuel Type	Gas	Type of Body	SUV
Colour	Silver

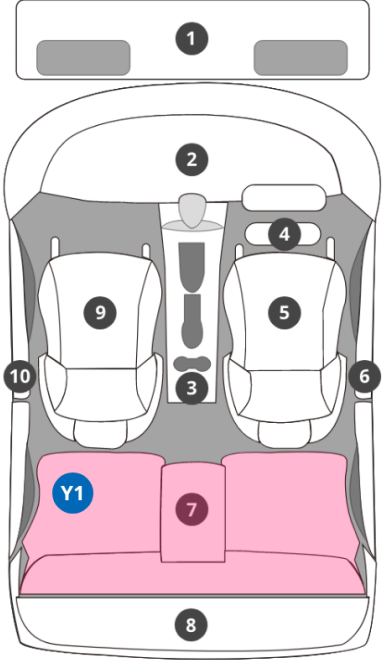
<p>a : Cut, Fray d : Loose, Deformed k : Animal Hair s : Smell t : Cigarette Burns x : Defective y : Stain</p>

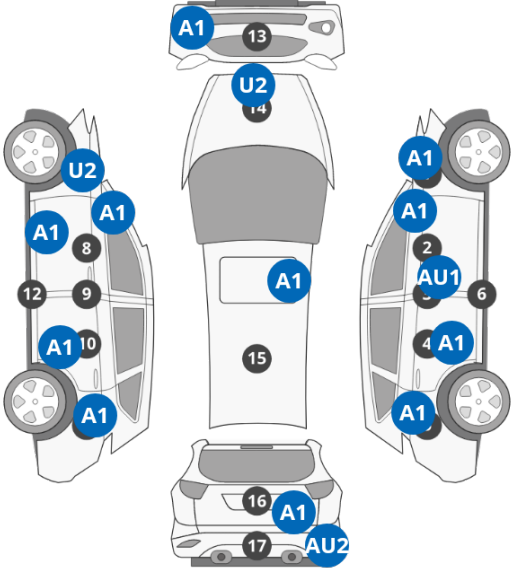
<p>A : Scratch AU : Scratch & Dent B : Modified C : Corrosion G : Stone chip P : Faded S : Rust SC : Rust & Corrosion U : Dent X : Defective Y : Crack, Gap</p>
<p>Remarks Rear Seat - Grime - Minimal</p>	<p>Remarks (R) Front Fender, Molding - Scratch - Minimal / (R) Front Door, Molding - Scratch & Dent - Minimal / (R) Mirror - Scratch - Minimal / (R) Rear Door, Molding - Scratch - Minimal / (R) Rear Fender, Molding - Scratch - Minimal / Rear Bumper, Lamps, Panels - Scratch & Dent - Small / Trunk Hood, Rear Gate - Scratch - Minimal / (L) Rear Fender, Molding - Scratch - Minimal / (L) Rear Door, Molding - Scratch - Minimal / (L) Mirror - Scratch - Minimal / (L) Front Door, Molding - Scratch - Minimal / Roof - Scratch - Minimal / (L) Front Fender, Molding - Dent - Small / Front Bumper, Grille, Lamps - Scratch - Minimal / Bonnet, Headlight - Dent - Small</p>
