General Information

Make	Toyota	Model	Vios
YOM	2023	Odo Meter Reading	55,940
Registration No.	NFB1284	Chassis No.	PA1B18F36P4294347
CC	1.3	Transmission	CVT
Fuel Type	Gas	Type of Body	Sedan
Colour	Red Mica Metallic

Body / Panel Condition

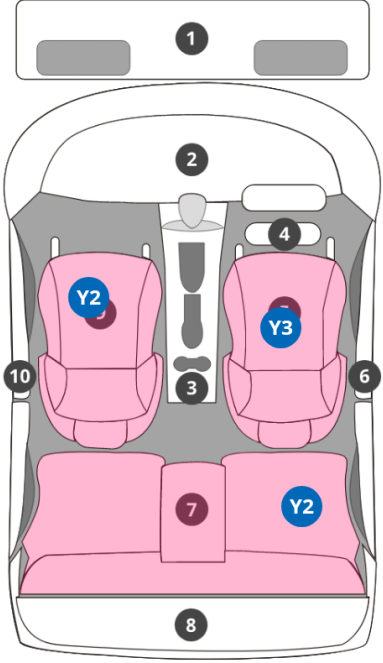
Interior Evaluation : B	Exterior Evaluation : C

<p>a : Cut, Fray d : Loose, Deformed k : Animal Hair s : Smell t : Cigarette Burns x : Defective y : Stain</p>

<p>A : Scratch AU : Scratch & Dent B : Modified C : Corrosion G : Stone chip P : Faded S : Rust SC : Rust & Corrosion U : Dent X : Defective Y : Crack, Gap</p>
<p>Remarks Rear Seat - Grime - Small / (R) Front Seat - Grime - Medium / (L) Front Seat - Grime - Small</p>	<p>Remarks (R) Rear Fender - Repair Traces - Yes / (R) Rear Fender, Molding - Repair mark - Yes / Rear Bumper, Lamps, Panels - Scratch - Medium / (R) Rear Door, Molding - Scratch & Dent - Small / (R) Rear Fender, Molding - Scratch - Minimal / (R) Front Door, Molding - Scratch - Minimal / Front Bumper, Grille, Lamps - Scratch - Medium / (R) Front Fender, Molding - Scratch - Minimal / (R) Mirror - Scratch - Minimal / (L) Mirror - Scratch - Minimal / (L) Front Fender, Molding - Dent - Minimal / (L) Rear Door, Molding - Scratch - Minimal / (L) Front Door, Molding - Scratch - Minimal / (L) Rear Fender, Molding - Scratch - Small</p>
