General Information

Make	Toyota	Model	Vios
YOM	2024	Odo Meter Reading	47,917
Registration No.	NFF2485	Chassis No.	PA1B18F35P4233787
CC	1.3	Transmission	CVT
Fuel Type	Gas	Type of Body	Sedan
Colour	Silver

Body / Panel Condition

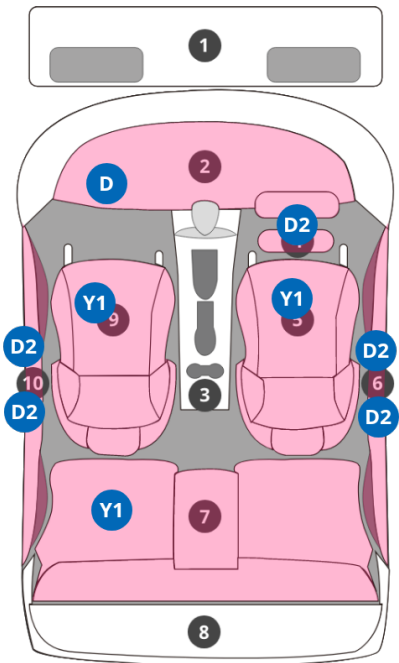
Interior Evaluation : B	Exterior Evaluation : D

<p>a : Cut, Fray d : Loose, Deformed k : Animal Hair s : Smell t : Cigarette Burns x : Defective y : Stain</p>

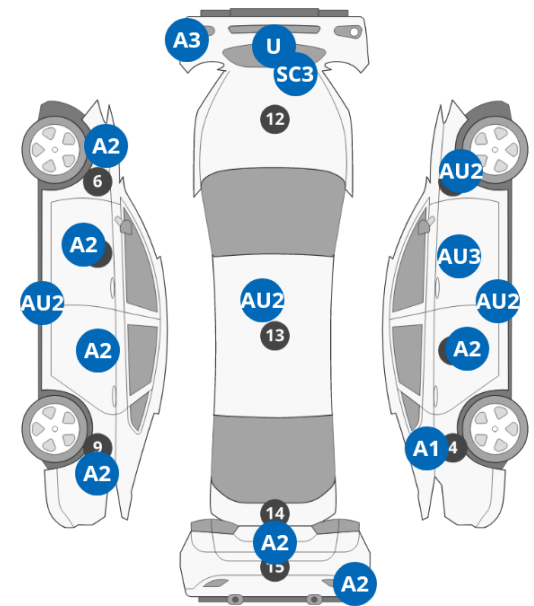
<p>A : Scratch AU : Scratch & Dent B : Modified C : Corrosion G : Stone chip P : Faded S : Rust SC : Rust & Corrosion U : Dent X : Defective Y : Crack, Gap</p>
<p>Remarks (L) Front Floor Mat - Worked - Small / (L) Front Trim - Worked - Small / (R) Front Trim - Worked - Small / (L) Rear Trim - Worked - Small / (R) Rear Trim - Worked - Small / (R) Front Seat - Grime - Minimal / Rear Seat - Grime - Minimal / (L) Front Seat - Grime - Minimal / Dashboard - Traces of Adhesive Tape - Yes</p>	<p>Remarks (R) Front Fender, Molding - Scratch & Dent - Small / (R) Front Door, Molding - Scratch & Dent - Medium / (R) Rear Door, Molding - Scratch - Small / (R) Step, In-panel, Side Spoiler - Scratch & Dent - Small / (R) Rear Fender, Molding - Scratch - Minimal / Rear Bumper, Lamps, Panels - Scratch - Small / Trunk Hood, Rear Gate - Scratch - Small / (L) Step, In-panel, Side Spoiler - Scratch & Dent - Small / (L) Rear Door, Molding - Scratch - Small / (L) Front Door, Molding - Scratch - Small / Front Bumper, Grille, Lamps - Scratch - Medium / Member (Bolted) - Dent - Yes / Roof - Scratch & Dent - Small / (L) Front Fender, Molding - Scratch - Small / (L) Rear Fender, Molding - Scratch - Small / Bonnet, Headlight - Rust, Corrosion - Medium</p>

<p>Inspector Notes</p>
<p>with LTO plate but Incomplete rear plate is temporary plate,with Sparetire and Jack. No warranty booklet and Tools. Busted Plate light. Scratch headlight and tail light.</p>
