General Information

Make	Toyota	Model	Vios
YOM	2022	Odo Meter Reading	31,693
Registration No.	NFL9799	Chassis No.	PA1B18F32N4178955
CC	1.3	Transmission	CVT
Fuel Type	Gas	Type of Body	Sedan
Colour	Green

Body / Panel Condition

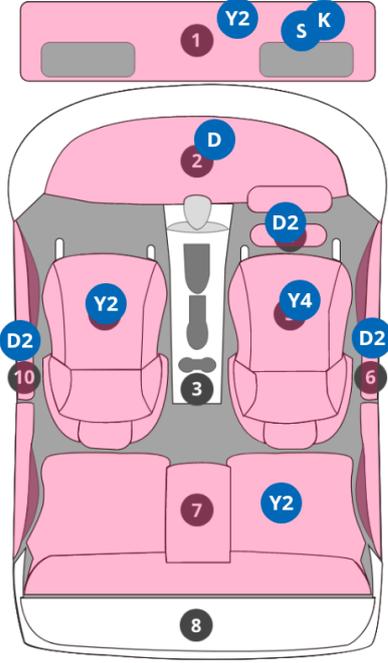
Interior Evaluation : C	Exterior Evaluation : D

<p>a : Cut, Fray d : Loose, Deformed k : Animal Hair s : Smell t : Cigarette Burns x : Defective y : Stain</p>

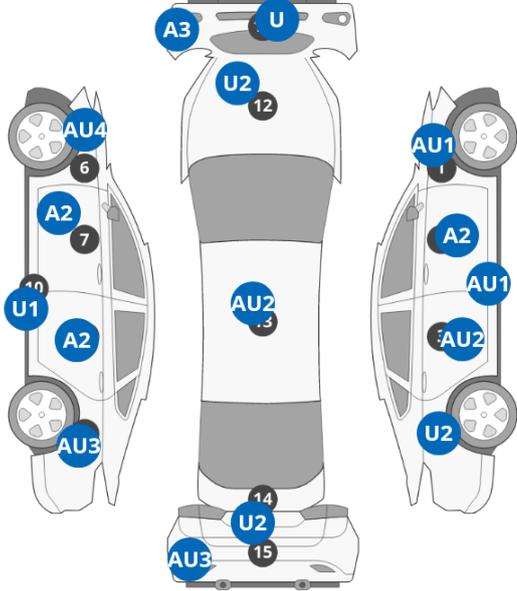
<p>A : Scratch AU : Scratch & Dent B : Modified C : Corrosion G : Stone chip P : Faded S : Rust SC : Rust & Corrosion U : Dent X : Defective Y : Crack, Gap</p>
<p>Remarks (R) Front Seat - Grime - Large / (L) Front Floor Mat - Worked - Small / Rear Seat - Grime - Small / (L) Front Seat - Grime - Small / (L) Front Trim - Worked - Small / (R) Front Trim - Worked - Small / Dashboard - Traces of Adhesive Tape - Yes / Ceiling - Grime - Small / Overall Interior - Smell - Yes / Overall Interior - Animal Hair - Yes</p>	<p>Remarks (L) Front Fender, Molding - Scratch & Dent - Large / Front Bumper, Grille, Lamps - Scratch - Medium / Member (Bolted) - Dent - Yes / (L) Rear Fender, Molding - Scratch & Dent - Medium / Rear Bumper, Lamps, Panels - Scratch & Dent - Medium / Trunk Hood, Rear Gate - Dent - Small / (R) Rear Fender, Molding - Dent - Small / (R) Rear Door, Molding - Scratch & Dent - Small / (R) Front Door, Molding - Scratch - Small / (R) Step, In-panel, Side Spoiler - Scratch & Dent - Minimal / (L) Step, In-panel, Side Spoiler - Dent - Minimal / (R) Front Fender, Molding - Scratch & Dent - Minimal / (L) Rear Door, Molding - Scratch - Small / (L) Front Door, Molding - Scratch - Small / Bonnet, Headlight - Dent - Small / Roof - Scratch & Dent - Small</p>

<p>Inspector Notes</p>
<p>With LTO plate and warranty booklet and Sparetire, Jack and Incomplete Tools. Scratch headlight and Crack Tail light, busted Plate light, worn Sparetire.</p>
