General Information

Make	Toyota	Model	Vios
YOM	2024	Odo Meter Reading	43,501
Registration No.	NGC9075	Chassis No.	PA1B18F34R4243634
CC	1.3	Transmission	CVT
Fuel Type	Gas	Type of Body	Sedan
Colour	Black

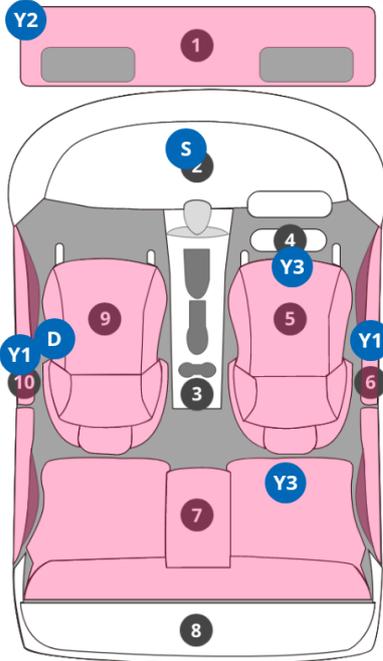
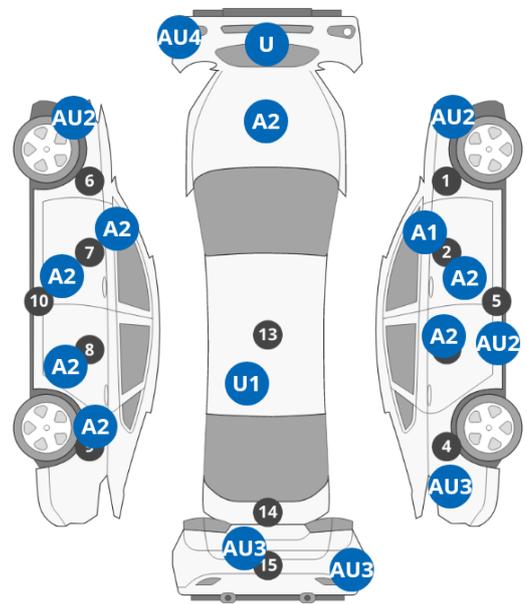
Interior Evaluation :	B	Exterior Evaluation :	E

<p>a : Cut, Fray d : Loose, Deformed k : Animal Hair s : Smell t : Cigarette Burns x : Defective y : Stain</p>		<p>A : Scratch AU : Scratch & Dent B : Modified C : Corrosion G : Stone chip P : Faded S : Rust SC : Rust & Corrosion U : Dent X : Defective Y : Crack, Gap</p>	
<p>Remarks (L) Front Seat - Worn - Yes / (R) Front Seat - Grime - Medium / Rear Seat - Grime - Medium / (R) Front Trim - Grime - Minimal / (L) Front Trim - Grime - Minimal / Overall Interior - Smell - Yes / Ceiling - Grime - Small</p>		<p>Remarks Trunk Hood, Rear Gate - Repair Traces - Yes / (R) Front Fender, Molding - Scratch & Dent - Small / (R) Mirror - Scratch - Minimal / (R) Step, In-panel, Side Spoiler - Scratch & Dent - Small / (R) Front Door, Molding - Scratch - Small / (R) Rear Door, Molding - Scratch - Small / (R) Rear Fender, Molding - Scratch & Dent - Medium / Rear Bumper, Lamps, Panels - Scratch & Dent - Medium / Trunk Hood, Rear Gate - Scratch & Dent - Medium / (L) Rear Fender, Molding - Scratch - Small / (L) Rear Door, Molding - Scratch - Small / (L) Front Door, Molding - Scratch - Small / (L) Mirror - Scratch - Small / (L) Front Fender, Molding - Scratch & Dent - Small / Front Bumper, Grille, Lamps - Scratch & Dent - Large / Member (Bolted) - Dent - Yes / Bonnet, Headlight - Scratch - Small / Roof - Dent - Minimal</p>

Inspector Notes
with warranty booklet, with jack and tools, with spare tire, with LTO plate, scratches on tail light, possible flooding
