General Information

Make	Toyota	Model	Innova
YOM	2023	Odo Meter Reading	78,976
Registration No.	NHI6551	Chassis No.	PA2JA8EM1P0122517
CC	2.8	Transmission	A/T
Fuel Type	Diesel	Type of Body	Wagon
Colour	Red Mica Metallic

Body / Panel Condition

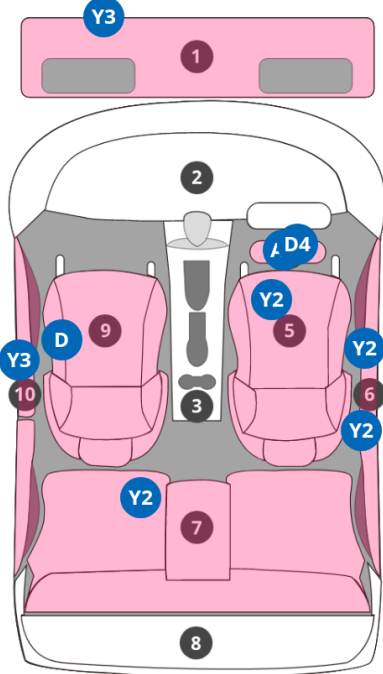
Interior Evaluation : C	Exterior Evaluation : E

<p>a : Cut, Fray d : Loose, Deformed k : Animal Hair s : Smell t : Cigarette Burns x : Defective y : Stain</p>

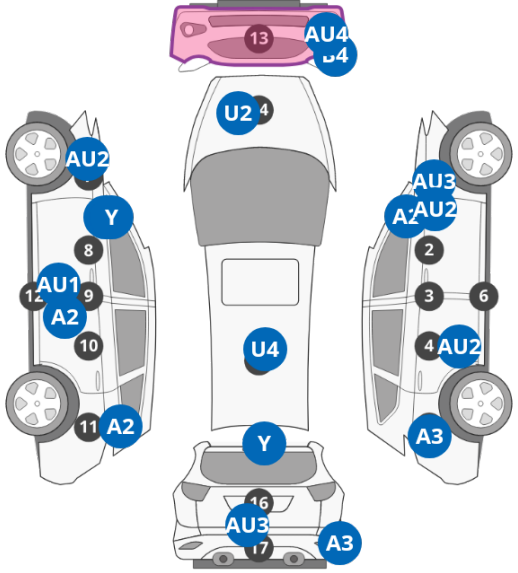
<p>A : Scratch AU : Scratch & Dent B : Modified C : Corrosion G : Stone chip P : Faded S : Rust SC : Rust & Corrosion U : Dent X : Defective Y : Crack, Gap</p>
<p>Remarks (L) Front Floor Mat - Cut, Crack - Medium / (L) Front Floor Mat - Worked - Large / (R) Front Seat - Grime - Small / (L) Front Seat - Worn - Yes / (R) Rear Trim - Grime - Small / Rear Seat - Grime - Small / (L) Front Trim - Grime - Medium / Ceiling - Grime - Medium / (R) Front Trim - Grime - Small</p>	<p>Remarks (L) Front Fender - Repair Traces - Yes / (R) Front Fender, Molding - Scratch & Dent - Medium / (R) Mirror - Scratch - Small / (R) Front Door, Molding - Scratch & Dent - Small / (R) Rear Door, Molding - Scratch & Dent - Small / (R) Rear Fender, Molding - Scratch - Medium / Trunk Hood, Rear Gate - Scratch & Dent - Medium / Rear Bumper, Lamps, Panels - Scratch - Medium / (L) Rear Fender, Molding - Scratch - Small / (L) Front Door, Molding - Scratch & Dent - Minimal / (L) Rear Door, Molding - Scratch - Small / (L) Mirror - Scratch - Small / (L) Front Fender, Molding - Scratch & Dent - Small / Front Bumper, Grille, Lamps - Repair mark - Yes / Front Bumper, Grille, Lamps - Modified - Large / Front Bumper, Grille, Lamps - Scratch & Dent - Large / Bonnet, Headlight - Dent - Small / Roof - Dent - Large / Antennae - Damaged - Yes / (L) Mirror - Crack - Damaged</p>

<p>Inspector Notes</p>	
<p>no warranty booklet, no jack, with tools, with spare tire, with LTO plate, scratches on headlight and tail light, cracked tail light, right fog lamp missing, left headlight deformed issue</p>
