## General Information

| Make | Toyota | Model | Avanza |
| YOM | 2023 | Mileage | 13,721 |
| Registration No. | NIN7201 | Chassis No. | MHFAA1BY6P0013523 |

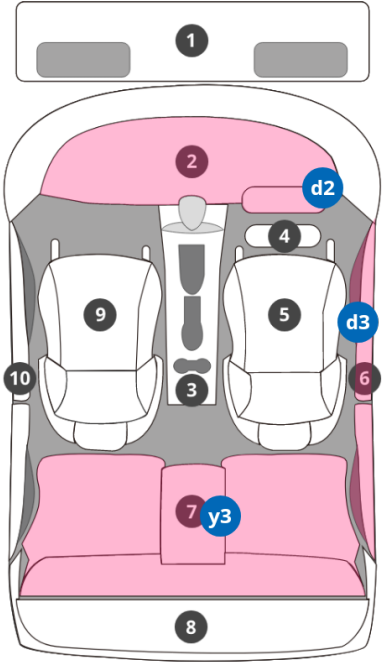
| Interior Evaluation : <b>B</b> | Exterior Evaluation : <b>D</b> |
| <b>Remarks</b><br>(R) Front Trim - Loose, Deformed - Medium / Rear Seat - Grime - Medium / Dashboard - Loose, Deformed - Small | <b>Remarks</b><br>(R) Front Fender - Repair Traces - Yes / Bonnet - Repair Traces - Yes / (R) Rear Door - Repair Traces - Yes / (R) Front Door, Molding - Scratch & Dent - Large / (R) Side Window - Damaged - Large / (R) Rear Door, Molding - Scratch & Dent - Small / (R) Front Fender, Molding - Scratch & Dent - Large / Rear Bumper, Lamps, Panels - Scratch & Dent - Medium / (L) Rear Fender, Molding - Dent - Minimal / Front Bumper, Grille, Lamps - Scratch & Dent - Small / (R) Mirror - Crack - Damaged |

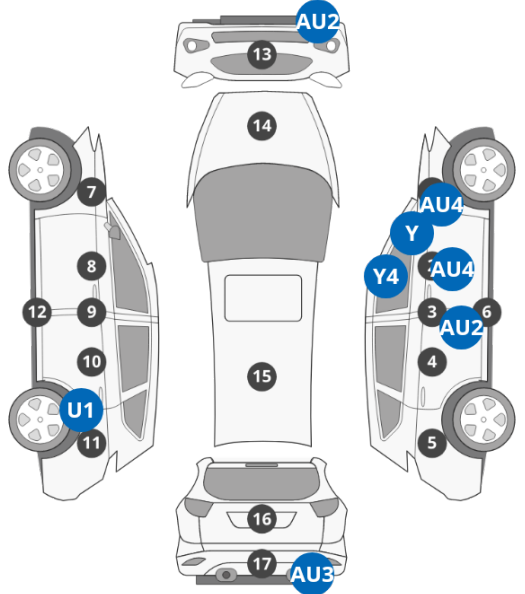
| Interior Evaluation : <b>B</b> | Exterior Evaluation : <b>D</b> |
|---|---|
| Frame Evaluation : <b>D</b> | Functional Evaluation : <b>C</b> |
| <b>Remarks</b><br>Right Front Pillar - Condition of Welding ? - Yes | <b>Remarks</b><br>Power Window (each) - Stuck, Gap - Yes / Door Lock - Issue - Yes / Spare Key - Issue - Unexist |
