General Information

Make	Toyota	Model	Vios
YOM	2024	Odo Meter Reading	22,968
Registration No.	NHS2498	Chassis No.	PA1B18F36R4259219
CC	1.3	Transmission	CVT
Fuel Type	Gas	Type of Body	Sedan
Colour	Black

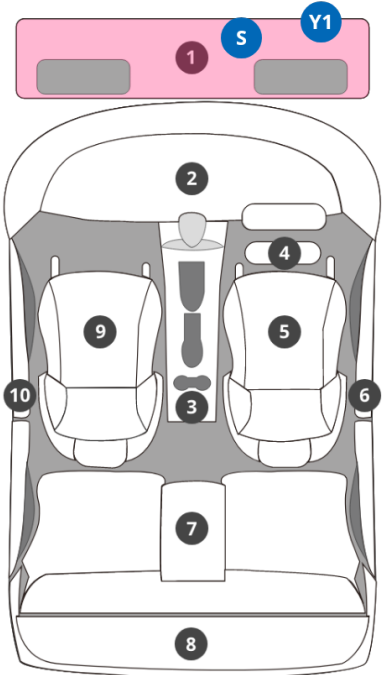
Interior Evaluation : B	Exterior Evaluation : C

<p>a : Cut, Fray d : Loose, Deformed k : Animal Hair s : Smell t : Cigarette Burns x : Defective y : Stain</p>

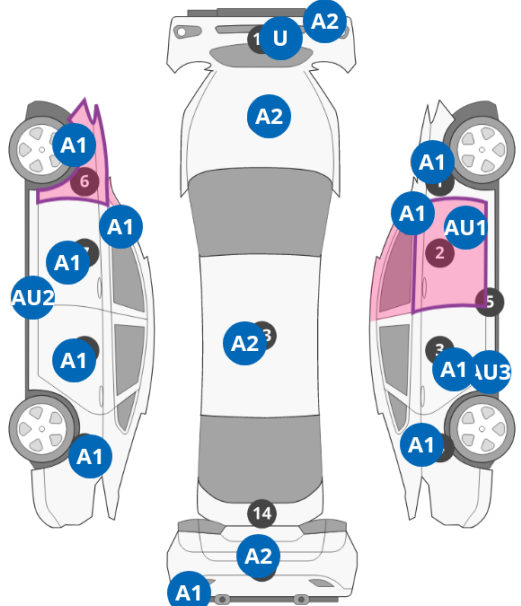
<p>A : Scratch AU : Scratch & Dent B : Modified C : Corrosion G : Stone chip P : Faded S : Rust SC : Rust & Corrosion U : Dent X : Defective Y : Crack, Gap</p>
Remarks Overall Interior - Smell - Yes / Ceiling - Grime - Minimal	Remarks (R) Front Door - Repair Traces - Yes / (R) Front Fender - Repair Traces - Yes / (R) Front Door, Molding - Repair mark - Yes / (R) Front Door, Molding - Scratch & Dent - Minimal / (R) Step, In-panel, Side Spoiler - Scratch & Dent - Medium / (R) Rear Door, Molding - Scratch - Minimal / (L) Front Fender, Molding - Repair mark - Yes / (R) Rear Fender, Molding - Scratch - Minimal / Trunk Hood, Rear Gate - Scratch - Small / Rear Bumper, Lamps, Panels - Scratch - Minimal / (L) Rear Fender, Molding - Scratch - Minimal / (L) Rear Door, Molding - Scratch - Minimal / (L) Step, In-panel, Side Spoiler - Scratch & Dent - Small / (L) Front Door, Molding - Scratch - Minimal / Member (Bolted) - Dent - Yes / (L) Front Fender, Molding - Scratch - Minimal / Bonnet, Headlight - Scratch - Small / Front Bumper, Grille, Lamps - Scratch - Small / Roof - Scratch - Small / (R) Front Fender, Molding - Scratch - Minimal / (R) Mirror - Scratch - Minimal / (L) Mirror - Scratch - Minimal
