General Information

Make	Toyota	Model	Raize
YOM	2023	Odo Meter Reading	33,139
Registration No.	NIO3390	Chassis No.	MHKAB1BA5PJ045147
CC	1.2	Transmission	CVT
Fuel Type	Gas	Type of Body	SUV
Colour	Silver

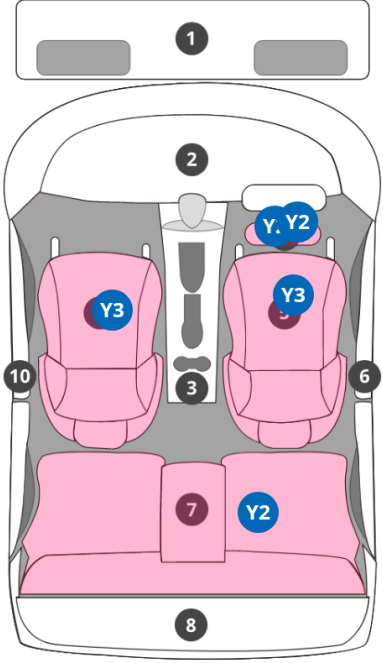
Interior Evaluation : B	Exterior Evaluation : C

<p>a : Cut, Fray d : Loose, Deformed k : Animal Hair s : Smell t : Cigarette Burns x : Defective y : Stain</p>

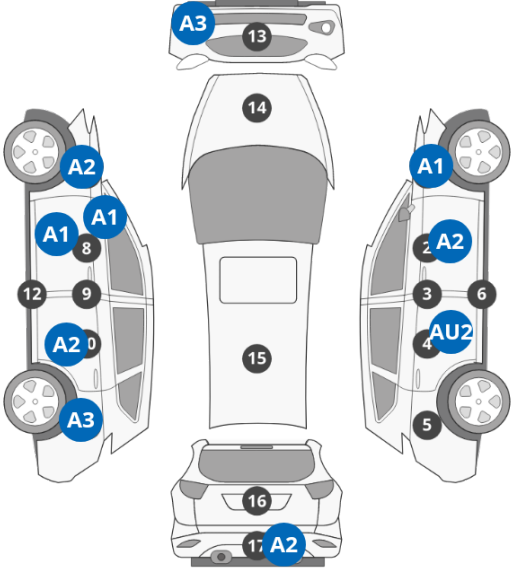
<p>A : Scratch AU : Scratch & Dent B : Modified C : Corrosion G : Stone chip P : Faded S : Rust SC : Rust & Corrosion U : Dent X : Defective Y : Crack, Gap</p>
<p>Remarks Rear Seat - Grime - Small / (R) Front Floor Mat - Grime - Small / (R) Front Seat - Grime - Medium / (L) Front Seat - Grime - Medium / (L) Front Floor Mat - Grime - Small</p>	<p>Remarks (R) Rear Door, Molding - Scratch & Dent - Small / Rear Bumper, Lamps, Panels - Scratch - Small / (L) Rear Fender, Molding - Scratch - Medium / (L) Rear Door, Molding - Scratch - Small / (L) Front Door, Molding - Scratch - Minimal / (L) Mirror - Scratch - Minimal / (L) Front Fender, Molding - Scratch - Small / Front Bumper, Grille, Lamps - Scratch - Medium / (R) Front Fender, Molding - Scratch - Minimal / (R) Front Door, Molding - Scratch - Small</p>
