General Information

Make	Toyota	Model	Vios
YOM	2024	Odo Meter Reading	28,951
Registration No.	NIU4124	Chassis No.	PA1B18F36P4237492
CC	1.3	Transmission	CVT
Fuel Type	Gas	Type of Body	Sedan
Colour	Red

Body / Panel Condition

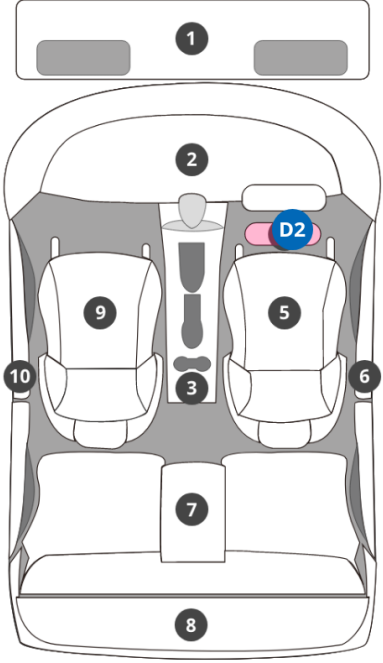
Interior Evaluation : A	Exterior Evaluation : B

<p>a : Cut, Fray d : Loose, Deformed k : Animal Hair s : Smell t : Cigarette Burns x : Defective y : Stain</p>

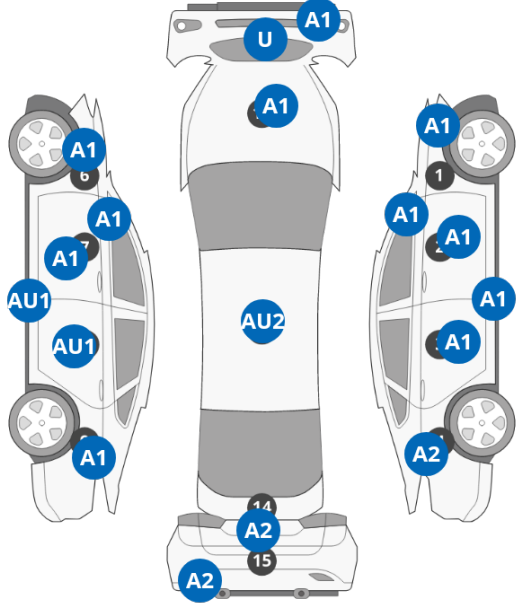
<p>A : Scratch AU : Scratch & Dent B : Modified C : Corrosion G : Stone chip P : Faded S : Rust SC : Rust & Corrosion U : Dent X : Defective Y : Crack, Gap</p>
Remarks (L) Front Floor Mat - Worked - Small	Remarks (R) Front Door, Molding - Scratch - Minimal / (R) Rear Door, Molding - Scratch - Minimal / (R) Step, In-panel, Side Spoiler - Scratch - Minimal / (R) Rear Fender, Molding - Scratch - Small / Rear Bumper, Lamps, Panels - Scratch - Small / (L) Rear Fender, Molding - Scratch - Minimal / (L) Rear Door, Molding - Scratch & Dent - Minimal / (L) Front Door, Molding - Scratch - Minimal / (L) Step, In-panel, Side Spoiler - Scratch & Dent - Minimal / (L) Front Fender, Molding - Scratch - Minimal / Member (Bolted) - Dent - Yes / Front Bumper, Grille, Lamps - Scratch - Minimal / (R) Front Fender, Molding - Scratch - Minimal / Bonnet, Headlight - Scratch - Minimal / Roof - Scratch & Dent - Small / Trunk Hood, Rear Gate - Scratch - Small / (R) Mirror - Scratch - Minimal / (L) Mirror - Scratch - Minimal

Inspector Notes
With LTO plate and warranty booklet and Sparetire, Jack. No Tools and Scratch headlight and tail light.
