General Information

Make	Toyota	Model	Vios
YOM	2022	Odo Meter Reading	78,597
Registration No.	CBE1875	Chassis No.	PA1B18F39N4185773
CC	1.3	Transmission	CVT
Fuel Type	Gas	Type of Body	Sedan
Colour	Red

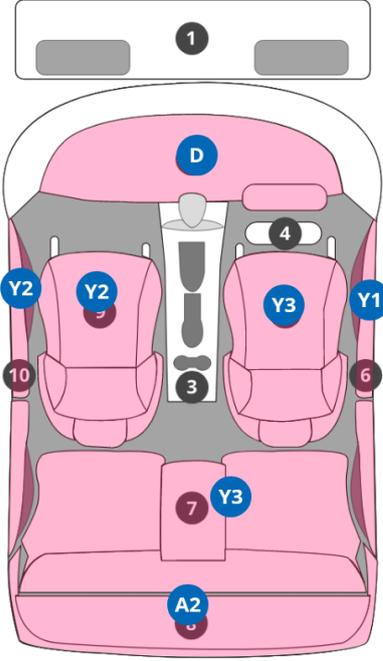
Interior Evaluation : B	Exterior Evaluation : D

<p>a : Cut, Fray d : Loose, Deformed k : Animal Hair s : Smell t : Cigarette Burns x : Defective y : Stain</p>

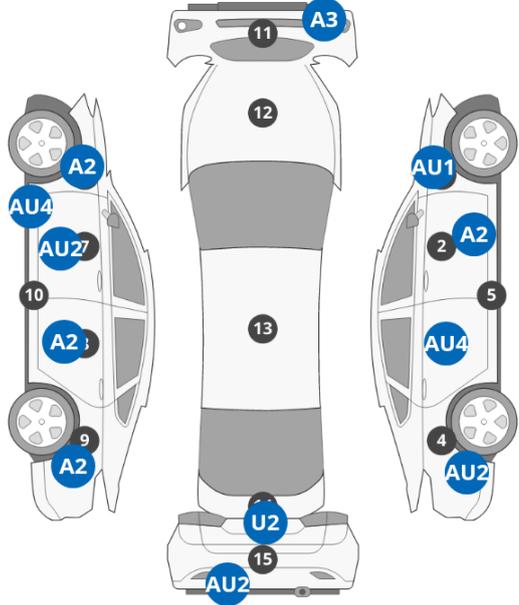
<p>A : Scratch AU : Scratch & Dent B : Modified C : Corrosion G : Stone chip P : Faded S : Rust SC : Rust & Corrosion U : Dent X : Defective Y : Crack, Gap</p>
<p>Remarks (L) Front Seat - Grime - Small / Trunk Room - Worn, Scratch, Cut, Crack - Small / Rear Seat - Grime - Medium / (R) Front Seat - Grime - Medium / (R) Front Trim - Grime - Minimal / (L) Front Trim - Grime - Small / Dashboard - Traces of Adhesive Tape - Yes</p>	<p>Remarks Trunk Hood, Rear Gate - Dent - Small / Rear Bumper, Lamps, Panels - Scratch & Dent - Small / (R) Rear Fender, Molding - Scratch & Dent - Small / (R) Rear Door, Molding - Scratch & Dent - Large / (R) Front Door, Molding - Scratch - Small / (R) Front Fender, Molding - Scratch & Dent - Minimal / Front Bumper, Grille, Lamps - Scratch - Medium / (L) Front Fender, Molding - Scratch - Small / (L) Front Door, Molding - Scratch & Dent - Small / (L) Step, In-panel, Side Spoiler - Scratch & Dent - Large / (L) Rear Door, Molding - Scratch - Small / (L) Rear Fender, Molding - Scratch - Small</p>
