General Information

Make	Toyota	Model	Vios
YOM	2023	Odo Meter Reading	29,457
Registration No.	DBG8225	Chassis No.	PA1B18F34P4203793
CC	1.3	Transmission	CVT
Fuel Type	Gas	Type of Body	Sedan
Colour	Red

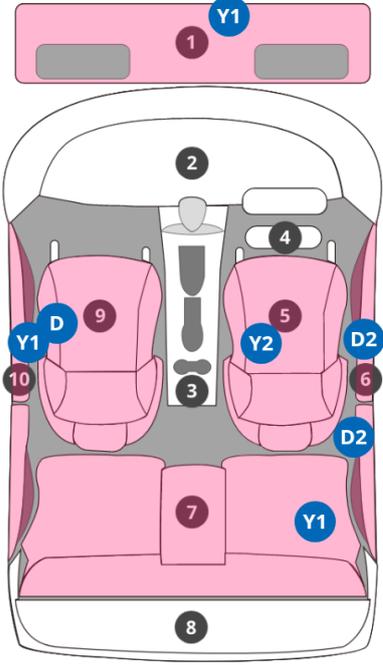
Interior Evaluation : B	Exterior Evaluation : D

<p>a : Cut, Fray d : Loose, Deformed k : Animal Hair s : Smell t : Cigarette Burns x : Defective y : Stain</p>

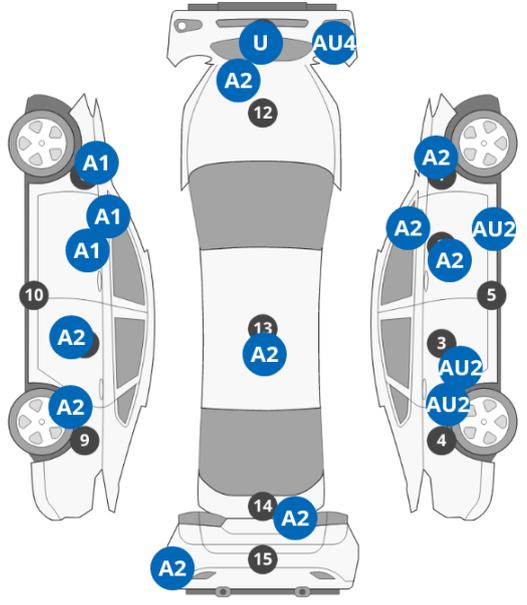
<p>A : Scratch AU : Scratch & Dent B : Modified C : Corrosion G : Stone chip P : Faded S : Rust SC : Rust & Corrosion U : Dent X : Defective Y : Crack, Gap</p>
<p>Remarks (R) Rear Trim - Worked - Small / (R) Front Seat - Grime - Small / Rear Seat - Grime - Minimal / (L) Front Trim - Grime - Minimal / (R) Front Trim - Worked - Small / (L) Front Seat - Worn - Yes / Ceiling - Grime - Minimal</p>	<p>Remarks (R) Front Door - Repair Traces - Yes / (R) Front Fender - Repair Traces - Yes / (L) Front Door - Repair Traces - Yes / (R) Rear Door - Repair Traces - Yes / Overall Exterior - Full Re-Paint in same color - Yes / (R) Front Fender, Molding - Scratch - Small / (R) Mirror - Scratch - Small / (R) Step, In-panel, Side Spoiler - Scratch & Dent - Small / (R) Front Door, Molding - Scratch - Small / (R) Rear Door, Molding - Scratch & Dent - Small / (R) Rear Fender, Molding - Scratch & Dent - Small / Rear Bumper, Lamps, Panels - Scratch - Small / Trunk Hood, Rear Gate - Scratch - Small / (L) Rear Fender, Molding - Scratch - Small / (L) Rear Door, Molding - Scratch - Small / (L) Front Door, Molding - Scratch - Minimal / (L) Mirror - Scratch - Minimal / Member (Bolted) - Dent - Yes / Front Bumper, Grille, Lamps - Scratch & Dent - Large / Bonnet, Headlight - Scratch - Small / (L) Front Fender, Molding - Scratch - Minimal / Roof - Scratch - Small</p>
