General Information

Make	Toyota	Model	Innova
YOM	2022	Odo Meter Reading	53,014
Registration No.	NEL7771	Chassis No.	PA2JA8EM5N0110867
CC	2.8	Transmission	A/T
Fuel Type	Diesel	Type of Body	Wagon
Colour	Red Mica Metallic

Body / Panel Condition

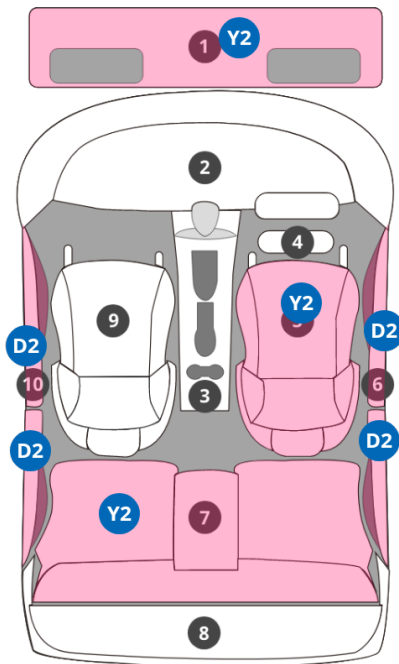
Interior Evaluation : B	Exterior Evaluation : C

<p>a : Cut, Fray d : Loose, Deformed k : Animal Hair s : Smell t : Cigarette Burns x : Defective y : Stain</p>

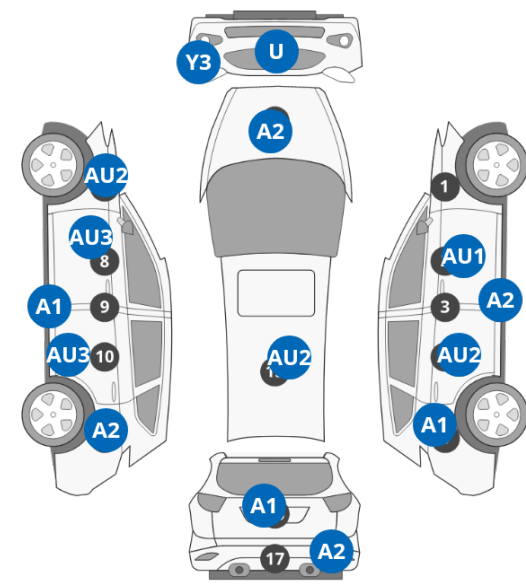
<p>A : Scratch AU : Scratch & Dent B : Modified C : Corrosion G : Stone chip P : Faded S : Rust SC : Rust & Corrosion U : Dent X : Defective Y : Crack, Gap</p>
<p>Remarks Rear Seat - Grime - Small / (R) Front Seat - Grime - Small / (L) Front Trim - Worked - Small / (L) Rear Trim - Worked - Small / (R) Front Trim - Worked - Small / (R) Rear Trim - Worked - Small / Ceiling - Grime - Small</p>	<p>Remarks (L) Rear Door, Molding - Scratch & Dent - Medium / (L) Step, In-panel, Side Spoiler - Scratch - Minimal / (L) Front Door, Molding - Scratch & Dent - Medium / (L) Rear Fender, Molding - Scratch - Small / (L) Front Fender, Molding - Scratch & Dent - Small / Front Bumper, Grille, Lamps - Crack, Gap - Medium / Member (Bolted) - Dent - Yes / (R) Front Door, Molding - Scratch & Dent - Minimal / (R) Rear Door, Molding - Scratch & Dent - Small / (R) Step, In-panel, Side Spoiler - Scratch - Small / (R) Rear Fender, Molding - Scratch - Minimal / Rear Bumper, Lamps, Panels - Scratch - Small / Trunk Hood, Rear Gate - Scratch - Minimal / Bonnet, Headlight - Scratch - Small / Roof - Scratch & Dent - Small</p>
