General Information

Make	Toyota	Model	Vios
YOM	2024	Odo Meter Reading	36,165
Registration No.	CCD1599	Chassis No.	PA1B18F39R4246626
CC	1.3	Transmission	CVT
Fuel Type	Gas	Type of Body	Sedan
Colour	Red

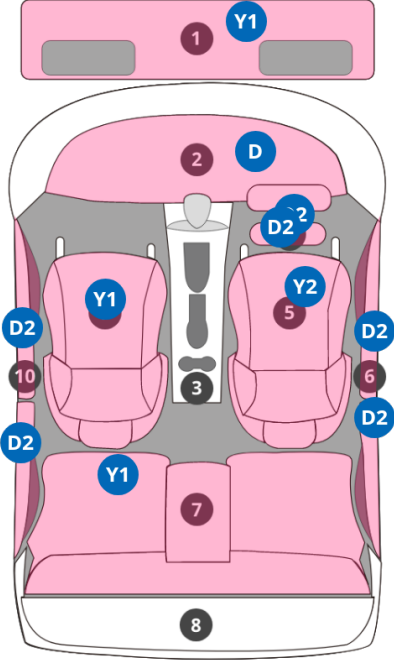
Interior Evaluation : B	Exterior Evaluation : C

<p>a : Cut, Fray d : Loose, Deformed k : Animal Hair s : Smell t : Cigarette Burns x : Defective y : Stain</p>

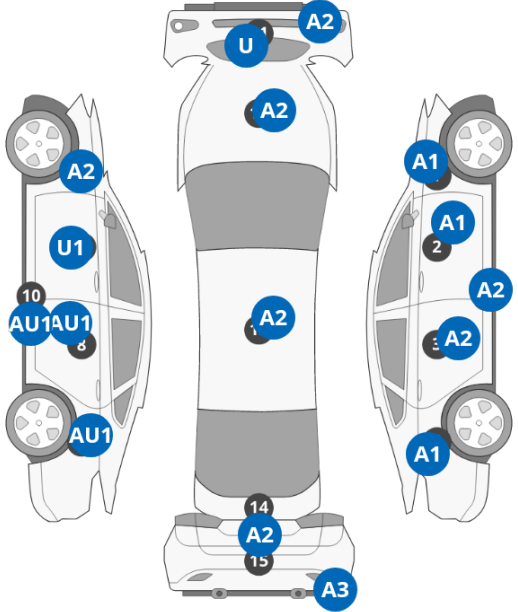
<p>A : Scratch AU : Scratch & Dent B : Modified C : Corrosion G : Stone chip P : Faded S : Rust SC : Rust & Corrosion U : Dent X : Defective Y : Crack, Gap</p>
Remarks (L) Front Floor Mat - Worked - Small / (R) Front Floor Mat - Worked - Small / Ceiling - Grime - Minimal / Dashboard - Traces of Adhesive Tape - Yes / Rear Seat - Grime - Minimal / (R) Front Seat - Grime - Small / (L) Front Seat - Grime - Minimal / (L) Front Trim - Worked - Small / (R) Front Trim - Worked - Small / (L) Rear Trim - Worked - Small / (R) Rear Trim - Worked - Small	Remarks (L) Front Door, Molding - Dent - Minimal / (L) Rear Door, Molding - Scratch & Dent - Minimal / (L) Rear Fender, Molding - Scratch & Dent - Minimal / (L) Step, In-panel, Side Spoiler - Scratch & Dent - Minimal / (L) Front Fender, Molding - Scratch - Small / Bonnet, Headlight - Scratch - Small / Member (Bolted) - Dent - Yes / Front Bumper, Grille, Lamps - Scratch - Small / (R) Front Fender, Molding - Scratch - Minimal / (R) Front Door, Molding - Scratch - Minimal / (R) Rear Door, Molding - Scratch - Small / (R) Step, In-panel, Side Spoiler - Scratch - Small / (R) Rear Fender, Molding - Scratch - Minimal / Rear Bumper, Lamps, Panels - Scratch - Medium / Trunk Hood, Rear Gate - Scratch - Small / Roof - Scratch - Small

Inspector Notes
With LTO plate and Sparetire, Incomplete Tools. No warranty booklet and Jack, Scratch headlight and tail light, Crack right tail light. worn tires and Sparetire.
