General Information

Make	Toyota	Model	Wigo
YOM	2024	Odo Meter Reading	23,246
Registration No.	NHS1485	Chassis No.	MHKAA1BCPJ008393
CC	1.0	Transmission	CVT
Fuel Type	Gas	Type of Body	Hatchback
Colour	Gray

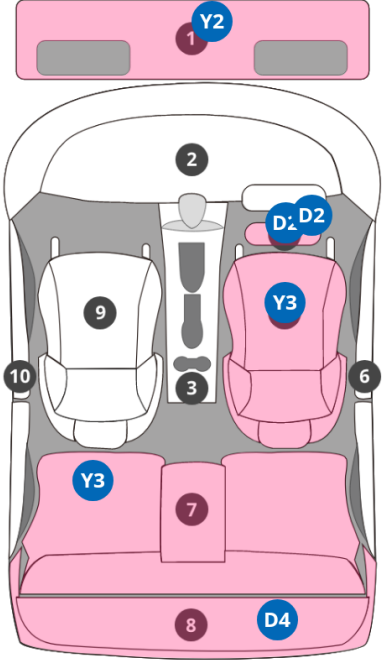
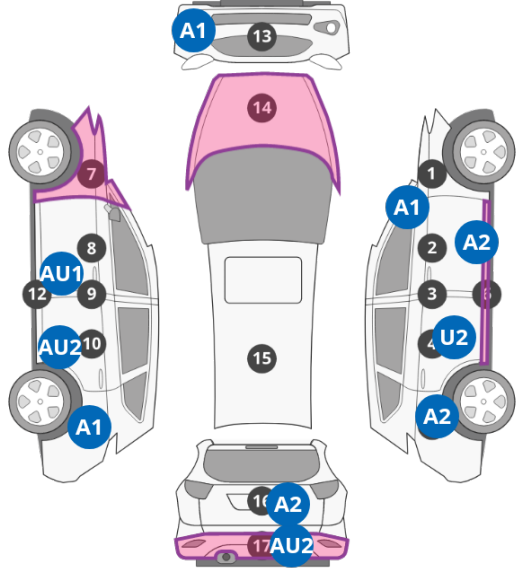
Interior Evaluation :	C	Exterior Evaluation :	C

<p>a : Cut, Fray d : Loose, Deformed k : Animal Hair s : Smell t : Cigarette Burns x : Defective y : Stain</p>		<p>A : Scratch AU : Scratch & Dent B : Modified C : Corrosion G : Stone chip P : Faded S : Rust SC : Rust & Corrosion U : Dent X : Defective Y : Crack, Gap</p>	
<p>Remarks (L) Front Floor Mat - Worked - Small / Ceiling - Grime - Small / (R) Front Floor Mat - Worked - Small / (R) Front Seat - Grime - Medium / Trunk Room - Loose, Deformed - Large / Rear Seat - Grime - Medium</p>		<p>Remarks Bonnet - Repair Traces - Yes / (L) Front Fender - Repair Traces - Yes / Bonnet, Headlight - Repair mark - Yes / (R) Mirror - Scratch - Minimal / (R) Step, In-panel, Side Spoiler - Repair mark - Yes / (R) Front Door, Molding - Scratch - Small / (R) Rear Door, Molding - Dent - Small / (R) Rear Fender, Molding - Scratch - Small / Rear Bumper, Lamps, Panels - Scratch & Dent - Small / Trunk Hood, Rear Gate - Scratch - Small / Rear Bumper, Lamps, Panels - Repair mark - Yes / (L) Rear Fender, Molding - Scratch - Minimal / (L) Rear Door, Molding - Scratch & Dent - Small / (L) Front Door, Molding - Scratch & Dent - Minimal / Front Bumper, Grille, Lamps - Scratch - Minimal / (L) Front Fender, Molding - Repair mark - Yes</p>
