General Information

Make	Toyota	Model	Innova
YOM	2025	Odo Meter Reading	9,241
Registration No.	BAG5977	Chassis No.	PA2JA8EMR0148488
CC	2.8	Transmission	A/T
Fuel Type	Diesel	Type of Body	Wagon
Colour	Silver

Body / Panel Condition

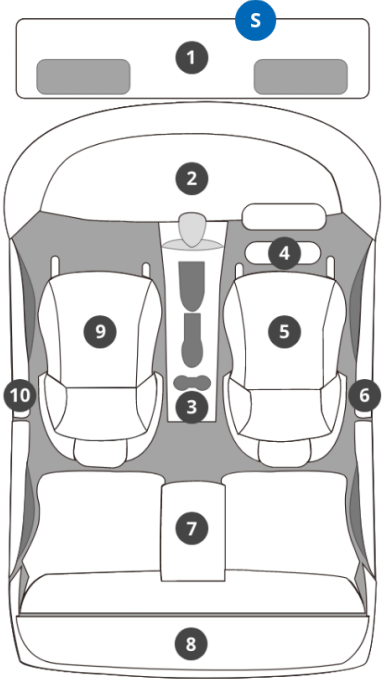
Interior Evaluation : B	Exterior Evaluation : B

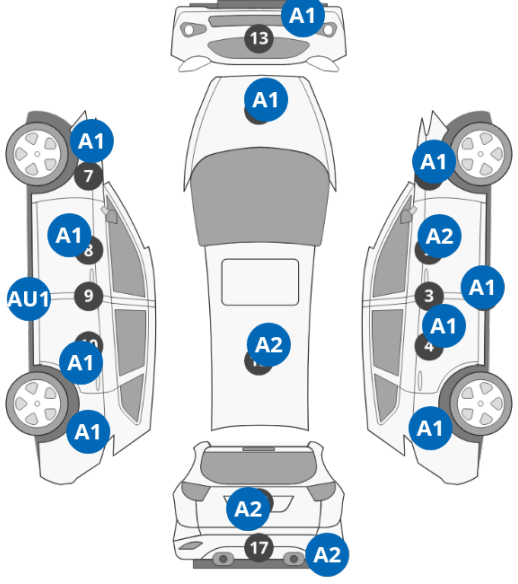
<p>A : Scratch AU : Scratch & Dent B : Modified C : Corrosion G : Stone chip P : Faded S : Rust SC : Rust & Corrosion U : Dent X : Defective Y : Crack, Gap</p>
Remarks Overall Interior - Smell - Yes	Remarks (L) Rear Door, Molding - Scratch - Minimal / (L) Rear Fender, Molding - Scratch - Minimal / (L) Front Door, Molding - Scratch - Minimal / (R) Front Door, Molding - Scratch - Small / (R) Rear Door, Molding - Scratch - Minimal / (R) Step, In-panel, Side Spoiler - Scratch - Minimal / (L) Step, In-panel, Side Spoiler - Scratch & Dent - Minimal / Bonnet, Headlight - Scratch - Minimal / Rear Bumper, Lamps, Panels - Scratch - Small / Trunk Hood, Rear Gate - Scratch - Small / (R) Rear Fender, Molding - Scratch - Minimal / Roof - Scratch - Small / Front Bumper, Grille, Lamps - Scratch - Minimal / (R) Front Fender, Molding - Scratch - Minimal / (L) Front Fender, Molding - Scratch - Minimal

Inspector Notes
With LTO plate and warranty booklet and Sparetire, Jack and Tools, Scratch headlight and tail light.
