## General Information

| Make | Toyota | Model | Hiace |
| Registration No. | VAB3803 | Chassis No. | JTFJT02P1N0015790 |

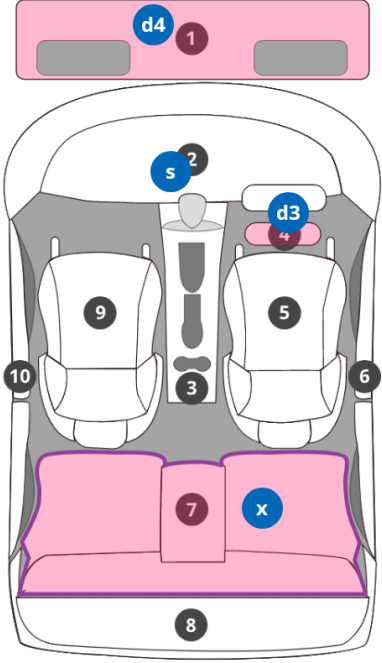
| Interior Evaluation : <b>C</b> | Exterior Evaluation : <b>E</b> |
| <p><b>Remarks</b></p> <p>Overall Interior - Worn as per age - Yes / Overall Interior - Smell - Yes / Ceiling - Loose, Deformed - Large / Rear Seat - Missing - Yes / Carpet - Loose, Deformed - Medium</p> | <p><b>Remarks</b></p> <p>Bonnet - Repair Traces - Yes / (R) Rear Fender, Molding - Scratch &amp; Dent - Large / Rear Bumper, Lamps, Panels - Scratch &amp; Dent - Medium / (L) Rear Fender, Molding - Scratch - Large / (L) Front Door, Molding - Scratch - Small / (R) Front Fender, Molding - Scratch - Medium / Roof - Scratch &amp; Dent - Large / Front Bumper, Grille, Lamps - Scratch &amp; Dent - Medium / Trunk Hood, Rear Gate - Scratch &amp; Dent - Small / Bonnet, Headlight - Repair mark - Yes / (L) Rear Wheel, Cover - Cap Missing - Yes / (L) Front Wheel, Cover - Cap Missing - Yes / (R) Front Wheel, Cover - Cap Missing - Yes / (R) Rear Wheel, Cover - Cap Missing - Yes / Bonnet, Headlight - Dent - Small</p> |
