General Information

Make	Toyota	Model	Rush
YOM	2021	Odo Meter Reading	45,687
Registration No.	NGR3566	Chassis No.	MHKE8FF3PLK027640
CC	1.5	Transmission	A/T
Fuel Type	Gas	Type of Body	SUV
Colour	White

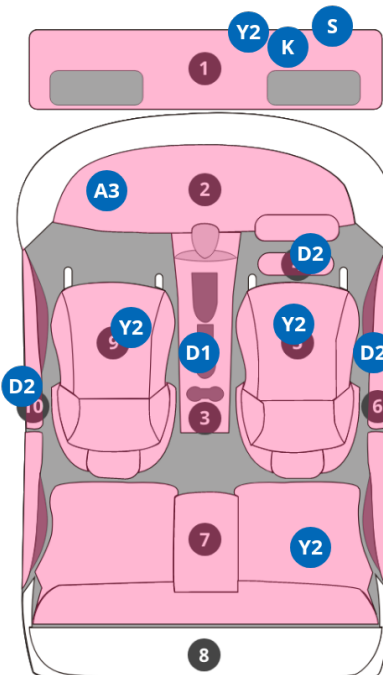
Interior Evaluation : C	Exterior Evaluation : E

<p>a : Cut, Fray d : Loose, Deformed k : Animal Hair s : Smell t : Cigarette Burns x : Defective y : Stain</p>

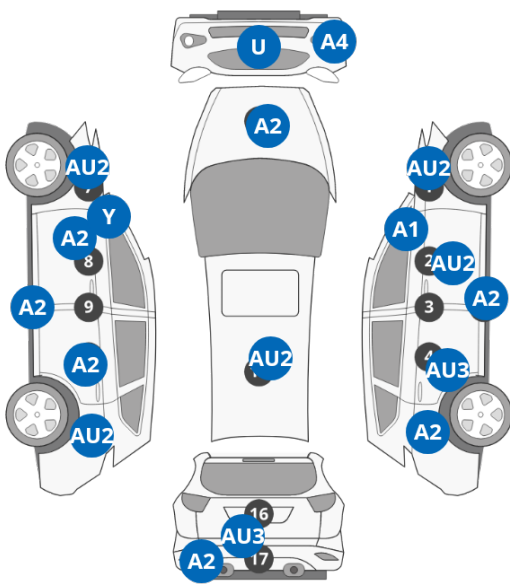
<p>A : Scratch AU : Scratch & Dent B : Modified C : Corrosion G : Stone chip P : Faded S : Rust SC : Rust & Corrosion U : Dent X : Defective Y : Crack, Gap</p>
<p>Remarks (L) Front Floor Mat - Worked - Small / Steering Wheel - Worn, Peel, Crack - Medium / (R) Front Seat - Grime - Small / (R) Front Trim - Worked - Small / (L) Front Trim - Worked - Small / Ceiling - Grime - Small / Overall Interior - Smell - Yes / Overall Interior - Animal Hair - Yes / Rear Seat - Grime - Small / (L) Front Seat - Grime - Small / Console, Switchs, Vents - Worked - Minimal</p>	<p>Remarks Front Bumper, Grille, Lamps - Scratch - Large / (R) Front Door, Molding - Scratch & Dent - Small / (R) Rear Door, Molding - Scratch & Dent - Medium / (R) Rear Fender, Molding - Scratch - Small / (R) Mirror - Scratch - Minimal / (R) Front Fender, Molding - Scratch & Dent - Small / Trunk Hood, Rear Gate - Scratch & Dent - Medium / Rear Bumper, Lamps, Panels - Scratch - Small / (L) Rear Fender, Molding - Scratch & Dent - Small / (R) Step, In-panel, Side Spoiler - Scratch - Small / (L) Step, In-panel, Side Spoiler - Scratch - Small / (L) Rear Door, Molding - Scratch - Small / (L) Front Door, Molding - Scratch - Small / (L) Front Fender, Molding - Scratch & Dent - Small / Bonnet, Headlight - Scratch - Small / Roof - Scratch & Dent - Small / Member (Bolted) - Dent - Yes / (L) Mirror - Crack - Damaged</p>
