General Information

Make	Toyota	Model	Vios
YOM	2025	Odo Meter Reading	18,357
Registration No.	NKG3135	Chassis No.	PA1B18F35R4270390
CC	1.3	Transmission	CVT
Fuel Type	Gas	Type of Body	Sedan
Colour	Silver

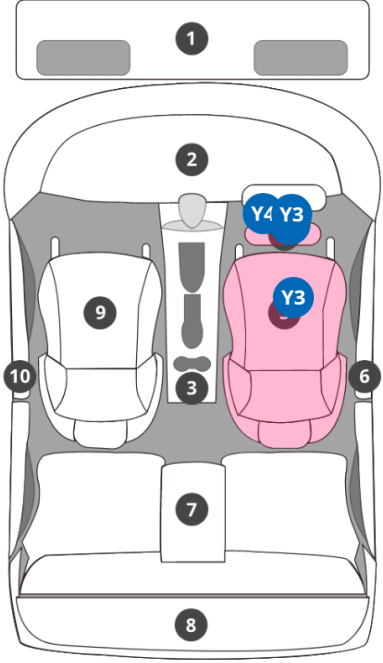
Interior Evaluation : C	Exterior Evaluation : C

<p>a : Cut, Fray d : Loose, Deformed k : Animal Hair s : Smell t : Cigarette Burns x : Defective y : Stain</p>

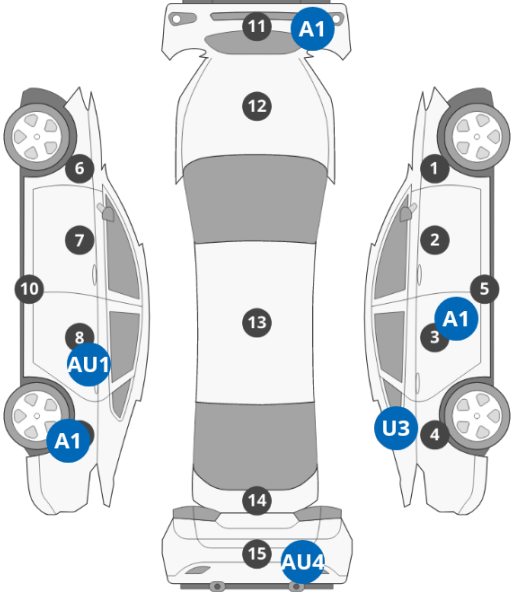
<p>A : Scratch AU : Scratch & Dent B : Modified C : Corrosion G : Stone chip P : Faded S : Rust SC : Rust & Corrosion U : Dent X : Defective Y : Crack, Gap</p>
<p>Remarks (R) Front Floor Mat - Grime - Large / (R) Front Seat - Grime - Medium / Mat Other - Grime - Large / (L) Front Floor Mat - Grime - Medium</p>	<p>Remarks (R) Rear Door, Molding - Scratch - Minimal / (R) Rear Fender, Molding - Dent - Medium / Rear Bumper, Lamps, Panels - Scratch & Dent - Large / (L) Rear Fender, Molding - Scratch - Minimal / (L) Front Door, Molding - Scratch & Dent - Minimal / Front Bumper, Grille, Lamps - Scratch - Minimal</p>
Frame Evaluation : A	Functional Evaluation : A
<p>Remarks Defects not found</p>	<p>Remarks Spare Key - Issue - Unexist</p>
