## General Information

<b>Make</b>	Toyota	<b>Model</b>	Vios
<b>YOM</b>	2025	<b>Odo Meter Reading</b>	4,395
<b>Registration No.</b>	CCG2275	<b>Chassis No.</b>	PA1B18F3XR4280235
<b>CC</b>	1.3	<b>Transmission</b>	CVT
<b>Fuel Type</b>	Gas	<b>Type of Body</b>	Sedan
<b>Colour</b>	Blue

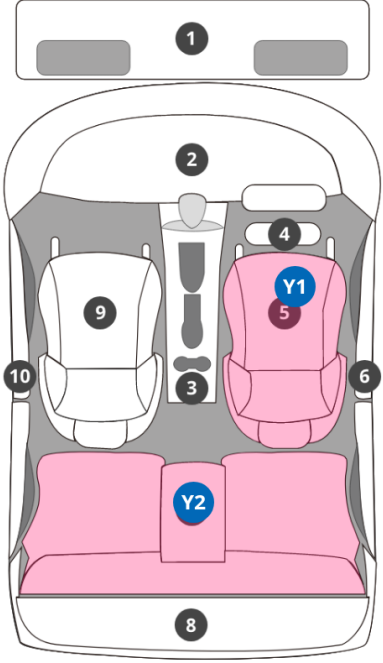
<p><b>a</b> : Cut, Fray <b>d</b> : Loose, Deformed <b>k</b> : Animal Hair <b>s</b> : Smell <b>t</b> : Cigarette Burns <b>x</b> : Defective <b>y</b> : Stain</p>

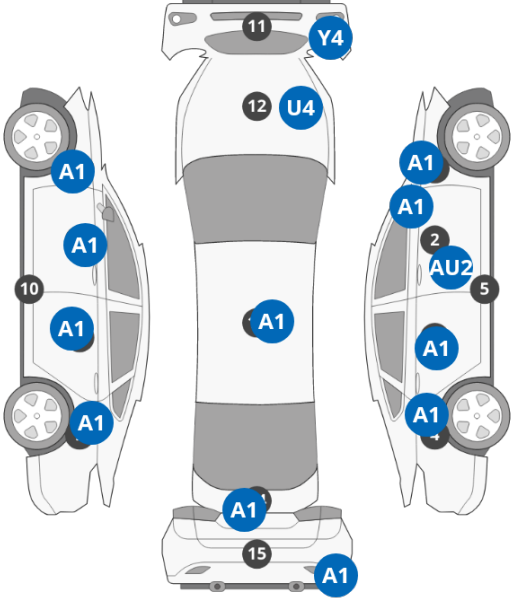
<p><b>A</b> : Scratch <b>AU</b> : Scratch &amp; Dent <b>B</b> : Modified <b>C</b> : Corrosion <b>G</b> : Stone chip <b>P</b> : Faded <b>S</b> : Rust <b>SC</b> : Rust &amp; Corrosion <b>U</b> : Dent <b>X</b> : Defective <b>Y</b> : Crack, Gap</p>
<p><b>Remarks</b> Rear Seat - Grime - Small / (R) Front Seat - Grime - Minimal</p>	<p><b>Remarks</b> (R) Front Fender, Molding - Scratch - Minimal / (R) Front Door, Molding - Scratch &amp; Dent - Small / (R) Mirror - Scratch - Minimal / (R) Rear Door, Molding - Scratch - Minimal / (R) Rear Fender, Molding - Scratch - Minimal / Rear Bumper, Lamps, Panels - Scratch - Minimal / Trunk Hood, Rear Gate - Scratch - Minimal / (L) Rear Fender, Molding - Scratch - Minimal / (L) Rear Door, Molding - Scratch - Minimal / (L) Front Door, Molding - Scratch - Minimal / (L) Front Fender, Molding - Scratch - Minimal / Front Bumper, Grille, Lamps - Crack, Gap - Large / Bonnet, Headlight - Dent - Large / Roof - Scratch - Minimal</p>
