General Information

Make	Toyota	Model	Vios
YOM	2025	Odo Meter Reading	6,506
Registration No.	CCG7769	Chassis No.	PA1B18F31S4283143
CC	1.3	Transmission	CVT
Fuel Type	Gas	Type of Body	Sedan
Colour	Blue

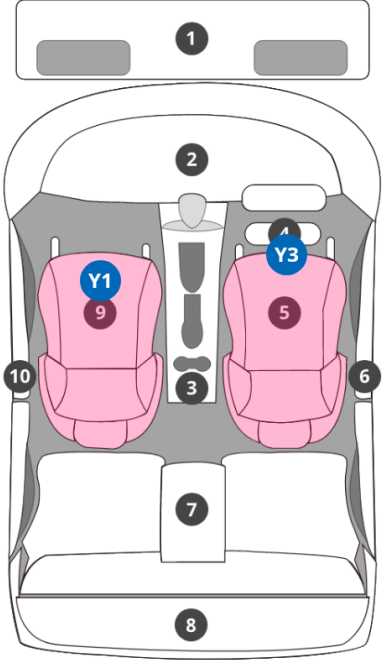
Interior Evaluation : B	Exterior Evaluation : B

<p>a : Cut, Fray d : Loose, Deformed k : Animal Hair s : Smell t : Cigarette Burns x : Defective y : Stain</p>

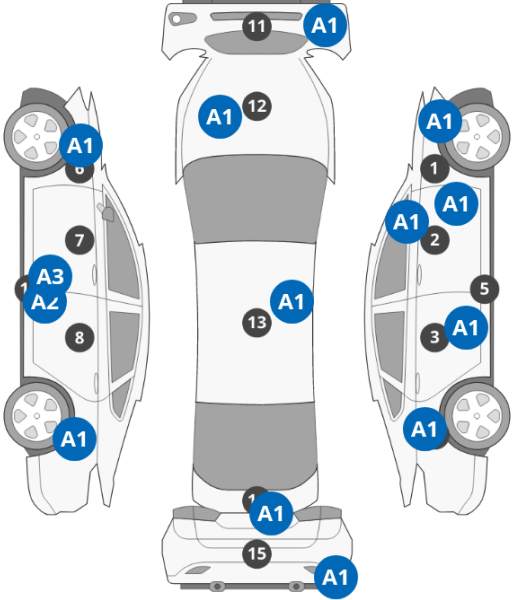
<p>A : Scratch AU : Scratch & Dent B : Modified C : Corrosion G : Stone chip P : Faded S : Rust SC : Rust & Corrosion U : Dent X : Defective Y : Crack, Gap</p>
<p>Remarks (L) Front Seat - Grime - Minimal / (R) Front Seat - Grime - Medium</p>	<p>Remarks (R) Front Fender, Molding - Scratch - Minimal / (R) Mirror - Scratch - Minimal / (R) Front Door, Molding - Scratch - Minimal / (R) Rear Door, Molding - Scratch - Minimal / (R) Rear Fender, Molding - Scratch - Minimal / Rear Bumper, Lamps, Panels - Scratch - Minimal / Trunk Hood, Rear Gate - Scratch - Minimal / (L) Rear Door, Molding - Scratch - Small / (L) Front Door, Molding - Scratch - Medium / (L) Rear Fender, Molding - Scratch - Minimal / Roof - Scratch - Minimal / (L) Front Fender, Molding - Scratch - Minimal / Front Bumper, Grille, Lamps - Scratch - Minimal / Bonnet, Headlight - Scratch - Minimal</p>
