General Information

Make	Toyota	Model	Vios
YOM	2024	Odo Meter Reading	3,852
Registration No.	NFR2940	Chassis No.	PA1B18F35R4245084
CC	1.3	Transmission	CVT
Fuel Type	Gas	Type of Body	Sedan
Colour	Black

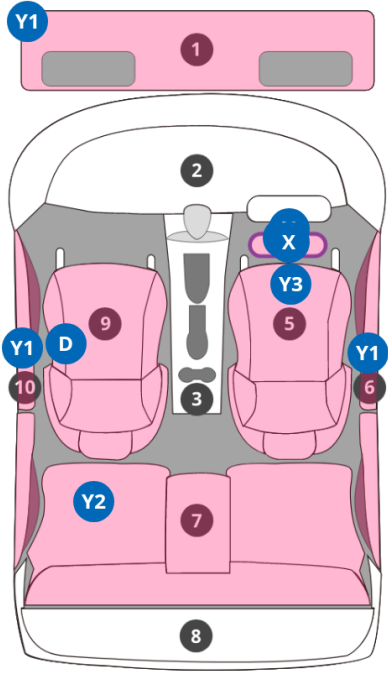
Interior Evaluation : B	Exterior Evaluation : E

<p>a : Cut, Fray d : Loose, Deformed k : Animal Hair s : Smell t : Cigarette Burns x : Defective y : Stain</p>

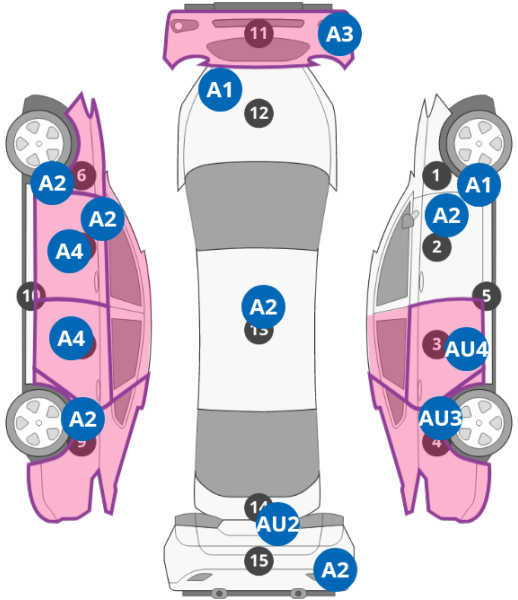
<p>A : Scratch AU : Scratch & Dent B : Modified C : Corrosion G : Stone chip P : Faded S : Rust SC : Rust & Corrosion U : Dent X : Defective Y : Crack, Gap</p>
<p>Remarks (R) Front Seat - Grime - Medium / (L) Front Seat - Worn - Yes / Rear Seat - Grime - Small / Mat Other - Missing - Yes / (L) Front Floor Mat - Missing - Yes / (R) Front Floor Mat - Missing - Yes / (R) Front Trim - Grime - Minimal / Ceiling - Grime - Minimal / (L) Front Trim - Grime - Minimal</p>	<p>Remarks (R) Front Fender, Molding - Scratch - Minimal / (R) Rear Door, Molding - Repair mark - Yes / (R) Rear Door, Molding - Scratch & Dent - Large / (R) Rear Fender, Molding - Repair mark - Yes / (R) Rear Fender, Molding - Scratch & Dent - Medium / (R) Front Door, Molding - Scratch - Small / Rear Bumper, Lamps, Panels - Scratch - Small / Trunk Hood, Rear Gate - Scratch & Dent - Small / (L) Rear Fender, Molding - Repair mark - Yes / (L) Rear Door, Molding - Repair mark - Yes / (L) Front Door, Molding - Repair mark - Yes / (L) Rear Fender, Molding - Scratch - Small / (L) Rear Door, Molding - Scratch - Large / (L) Front Door, Molding - Scratch - Large / (L) Mirror - Scratch - Small / (L) Front Fender, Molding - Scratch - Small / (L) Front Fender, Molding - Repair mark - Yes / Front Bumper, Grille, Lamps - Repair mark - Yes / Front Bumper, Grille, Lamps - Scratch - Medium / Bonnet, Headlight - Scratch - Minimal / Roof - Scratch - Small</p>
