General Information

Make	Toyota	Model	Vios
YOM	2022	Mileage	32,510
Registration No.	EAE7510	Chassis No.	PA1B18F34N4171246
CC	1.3	Transmission	CVT
Fuel Type	Gas	Type of Body	Sedan
Colour	Black

Body / Panel Condition

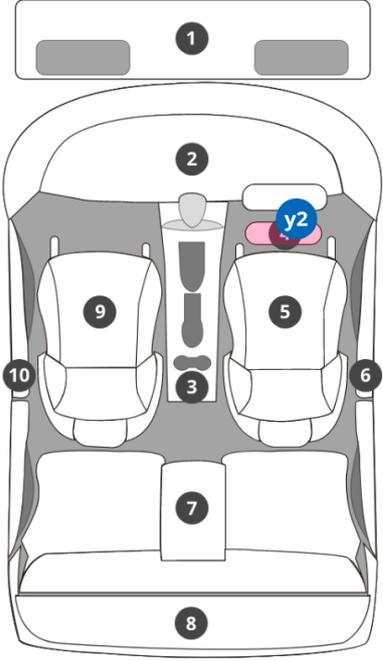
Interior Evaluation : A	Exterior Evaluation : B

<p>a : Cut, Fray d : Loose, Deformed k : Animal Hair s : Smell t : Cigarette Burns x : Defective y : Stain</p>

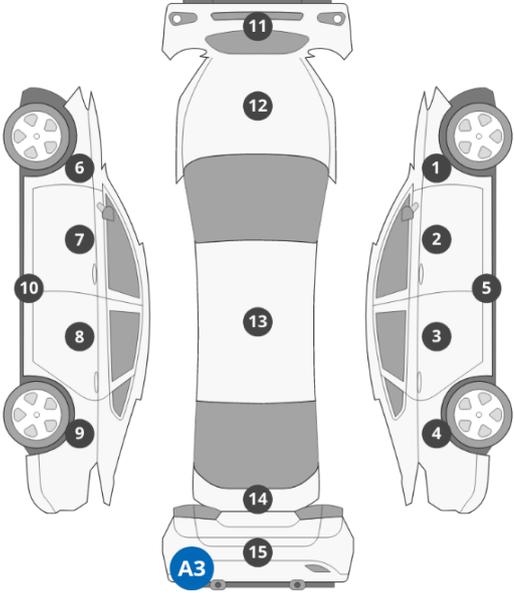
<p>A : Scratch AU : Scratch & Dent B : Modified C : Corrosion G : Stone chip P : Faded S : Rust SC : Rust & Corrosion U : Dent X : Defective Y : Crack, Gap</p>
Remarks (L) Front Floor Mat - Grime - Small	Remarks Rear Bumper, Lamps, Panels - Scratch - Medium
Frame Evaluation : A	Functional Evaluation : A
Remarks Defects not found	Remarks Spare Key - Issue - Unexist
