General Information

Make	Toyota	Model	Vios
YOM	2022	Odo Meter Reading	44,406
Registration No.	DAQ6983	Chassis No.	PA1B18F34N4178844
CC	1.3	Transmission	CVT
Fuel Type	Gas	Type of Body	Sedan
Colour	Blue

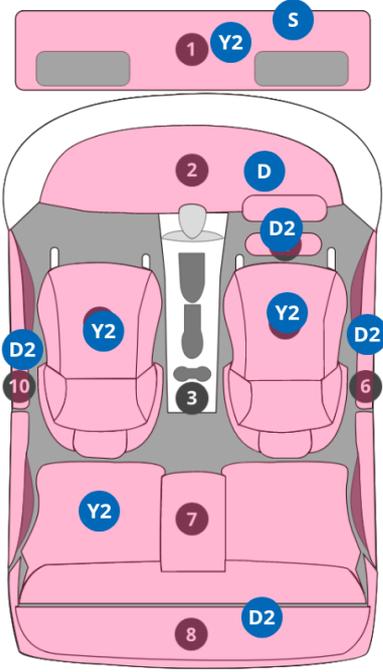
Interior Evaluation : C	Exterior Evaluation : B

<p>a : Cut, Fray d : Loose, Deformed k : Animal Hair s : Smell t : Cigarette Burns x : Defective y : Stain</p>

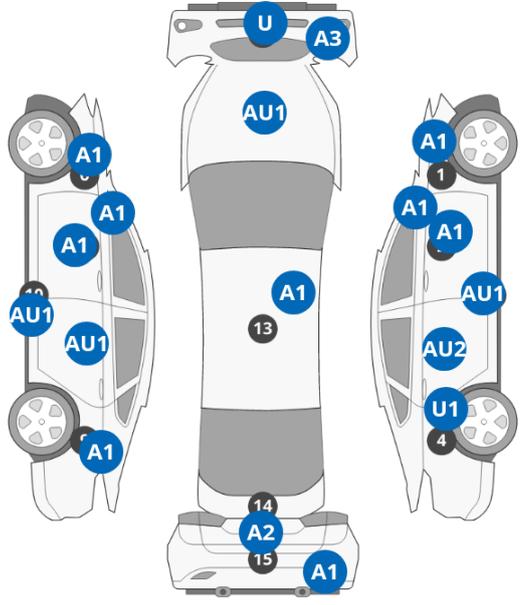
<p>A : Scratch AU : Scratch & Dent B : Modified C : Corrosion G : Stone chip P : Faded S : Rust SC : Rust & Corrosion U : Dent X : Defective Y : Crack, Gap</p>
<p>Remarks Rear Seat - Grime - Small / (R) Front Seat - Grime - Small / (R) Front Floor Mat - Worked - Small / (L) Front Floor Mat - Worked - Small / (L) Front Trim - Worked - Small / (R) Front Trim - Worked - Small / (L) Front Seat - Grime - Small / Dashboard - Traces of Adhesive Tape - Yes / Ceiling - Grime - Small / Overall Interior - Smell - Yes / Trunk Room - Loose, Deformed - Small</p>	<p>Remarks (L) Rear Door, Molding - Scratch & Dent - Minimal / (L) Rear Fender, Molding - Scratch - Minimal / (L) Step, In-panel, Side Spoiler - Scratch & Dent - Minimal / (L) Front Door, Molding - Scratch - Minimal / (L) Front Fender, Molding - Scratch - Minimal / Trunk Hood, Rear Gate - Scratch - Small / Rear Bumper, Lamps, Panels - Scratch - Minimal / (R) Rear Fender, Molding - Dent - Minimal / (R) Rear Door, Molding - Scratch & Dent - Small / (R) Step, In-panel, Side Spoiler - Scratch & Dent - Minimal / (R) Front Door, Molding - Scratch - Minimal / (R) Front Fender, Molding - Scratch - Minimal / Member (Bolted) - Dent - Yes / Bonnet, Headlight - Scratch & Dent - Minimal / Roof - Scratch - Minimal / Front Bumper, Grille, Lamps - Scratch - Medium / (R) Mirror - Scratch - Minimal / (L) Mirror - Scratch - Minimal</p>
