General Information

Make	Toyota	Model	Fortuner
YOM	2024	Odo Meter Reading	13,572
Registration No.	NFR2316	Chassis No.	MHFCB3GS9P0494874
CC	2.4	Transmission	A/T
Fuel Type	Diesel	Type of Body	SUV
Colour	Gray

Body / Panel Condition

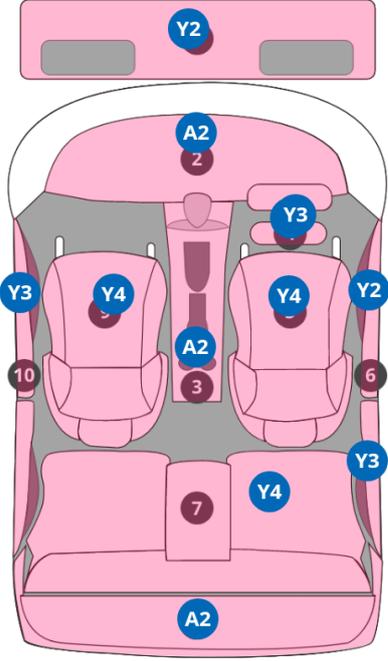
Interior Evaluation : E	Exterior Evaluation : E

<p>a : Cut, Fray d : Loose, Deformed k : Animal Hair s : Smell t : Cigarette Burns x : Defective y : Stain</p>

<p>A : Scratch AU : Scratch & Dent B : Modified C : Corrosion G : Stone chip P : Faded S : Rust SC : Rust & Corrosion U : Dent X : Defective Y : Crack, Gap</p>
Remarks Trunk Room - Worn, Scratch, Cut, Crack - Small / Rear Seat - Grime - Large / (R) Rear Trim - Grime - Medium / (R) Front Seat - Grime - Large / (R) Front Trim - Grime - Small / (R) Front Floor Mat - Grime - Medium / Mat Other - Grime - Medium / (L) Front Trim - Grime - Medium / (L) Front Seat - Grime - Large / Console, Switchs, Vents - Worn, Scratch, Cut, Crack - Small / Dashboard - Worn, Scratch, Cut, Crack - Small / Ceiling - Grime - Small	Remarks Trunk Hood, Rear Gate - Scratch - Large / Rear Bumper, Lamps, Panels - Scratch - Large / (L) Rear Fender, Molding - Scratch - Large / (R) Rear Fender, Molding - Scratch & Dent - Large / (R) Front Door, Molding - Scratch & Dent - Small / Front Bumper, Grille, Lamps - Scratch & Dent - Medium / (L) Front Fender, Molding - Scratch - Minimal / (L) Rear Door, Molding - Scratch - Large / (L) Front Door, Molding - Scratch - Small / Bonnet, Headlight - Scratch - Small / Roof - Scratch - Small / Member (Bolted) - Dent - Yes
