General Information

Make	Toyota	Model	Vios
YOM	2022	Odo Meter Reading	30,306
Registration No.	DAS6545	Chassis No.	PA1B18F39N4190150
CC	1.3	Transmission	CVT
Fuel Type	Gas	Type of Body	Sedan
Colour	Silver

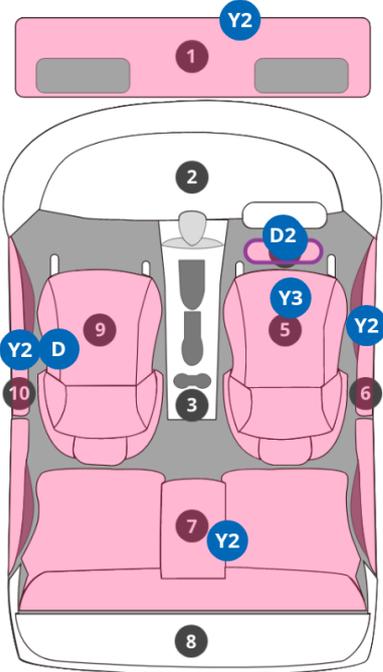
Interior Evaluation : B	Exterior Evaluation : D

<p>a : Cut, Fray d : Loose, Deformed k : Animal Hair s : Smell t : Cigarette Burns x : Defective y : Stain</p>

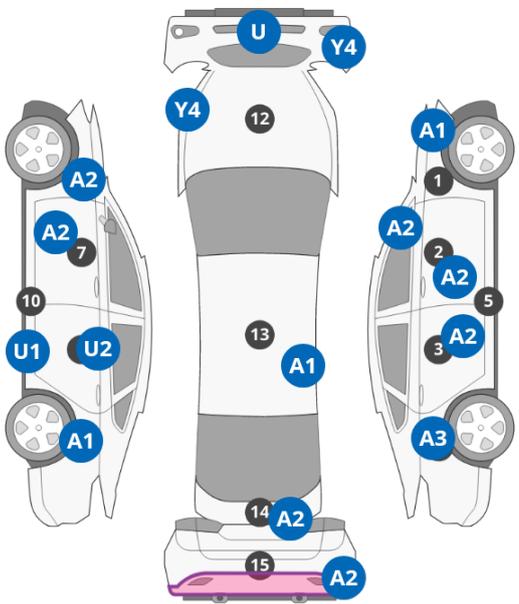
<p>A : Scratch AU : Scratch & Dent B : Modified C : Corrosion G : Stone chip P : Faded S : Rust SC : Rust & Corrosion U : Dent X : Defective Y : Crack, Gap</p>
<p>Remarks Mat Other - Missing - Yes / Rear Seat - Grime - Small / (R) Front Seat - Grime - Medium / (L) Front Seat - Worn - Yes / (R) Front Trim - Grime - Small / (L) Front Trim - Grime - Small / (L) Front Floor Mat - Worked - Small / Ceiling - Grime - Small</p>	<p>Remarks (R) Front Fender - Repair Traces - Yes / Bonnet - Repair Traces - Yes / (L) Front Fender - Repair Traces - Yes / (R) Rear Fender - Repair Traces - Yes / (R) Mirror - Scratch - Small / (R) Front Fender, Molding - Scratch - Minimal / (R) Front Door, Molding - Scratch - Small / (R) Rear Door, Molding - Scratch - Small / (R) Rear Fender, Molding - Scratch - Medium / Rear Bumper, Lamps, Panels - Repair mark - Yes / Rear Bumper, Lamps, Panels - Scratch - Small / Trunk Hood, Rear Gate - Scratch - Small / (L) Rear Fender, Molding - Scratch - Minimal / (L) Rear Door, Molding - Dent - Small / (L) Front Door, Molding - Scratch - Small / (L) Step, In-panel, Side Spoiler - Dent - Minimal / (L) Front Fender, Molding - Scratch - Small / Member (Bolted) - Dent - Yes / Front Bumper, Grille, Lamps - Crack, Gap - Large / Bonnet, Headlight - Crack, Gap - Large / Roof - Scratch - Minimal</p>

<p>Inspector Notes</p>
<p>no warranty booklet, no jack and tools, with spare tire, with LTO plate, scratches on tail light, engine hood latch issue</p>
