General Information

Make	Toyota	Model	Fortuner
YOM	2022	Odo Meter Reading	55,169
Registration No.	NIB5302	Chassis No.	MHFCB8GS4N0524874
CC	2.4	Transmission	A/T
Fuel Type	Diesel	Type of Body	SUV
Colour	Silver

Body / Panel Condition

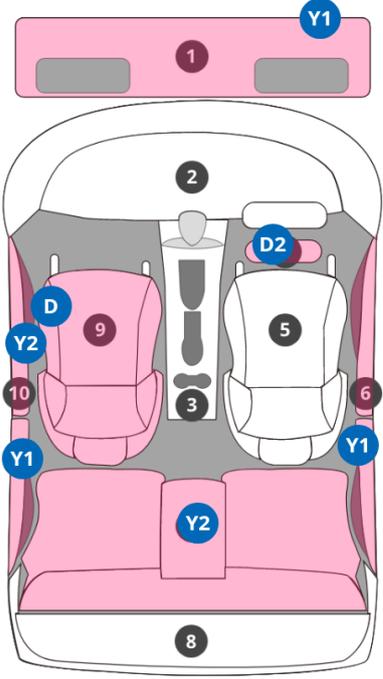
<p>a : Cut, Fray d : Loose, Deformed k : Animal Hair s : Smell t : Cigarette Burns x : Defective y : Stain</p>

<p>A : Scratch AU : Scratch & Dent B : Modified C : Corrosion G : Stone chip P : Faded S : Rust SC : Rust & Corrosion U : Dent X : Defective Y : Crack, Gap</p>
<p>Remarks Rear Seat - Grime - Small / (R) Rear Trim - Grime - Minimal / Ceiling - Grime - Minimal / (L) Front Trim - Grime - Small / (L) Rear Trim - Grime - Minimal / (L) Front Floor Mat - Worked - Small / (L) Front Seat - Worn - Yes</p>	<p>Remarks (R) Front Fender, Molding - Scratch - Minimal / (R) Front Door, Molding - Scratch - Minimal / (R) Rear Door, Molding - Scratch - Small / (R) Rear Fender, Molding - Scratch - Minimal / Rear Bumper, Lamps, Panels - Scratch - Small / Trunk Hood, Rear Gate - Scratch - Minimal / (L) Rear Door, Molding - Scratch & Dent - Small / (L) Mirror - Scratch - Minimal / (L) Front Door, Molding - Crack, Gap - Small / Front Bumper, Grille, Lamps - Scratch - Small / Bonnet, Headlight - Scratch - Minimal / Roof - Scratch - Small</p>

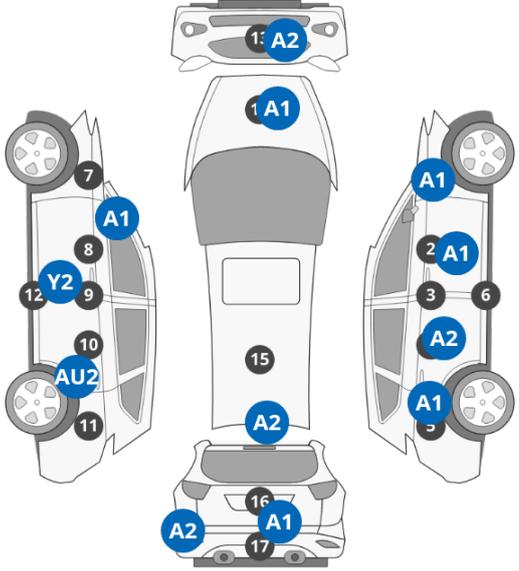
<p>Inspector Notes</p>
<p>no warranty booklet, with jack and tools, with spare tire, with LTO plate, scratches on tail light, rear left door speaker issue</p>
