General Information

Make	Toyota	Model	Wigo
YOM	2025	Odo Meter Reading	1,571
Registration No.	NKM7436	Chassis No.	MHKAA1BCXRJ033647
CC	1.0	Transmission	CVT
Fuel Type	Gas	Type of Body	Hatchback
Colour	Orange

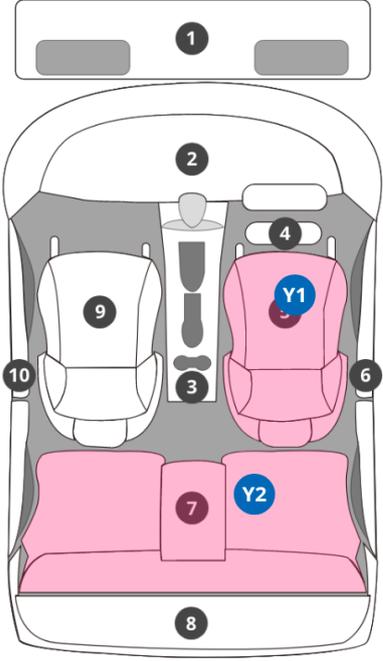
Interior Evaluation : A	Exterior Evaluation : C

<p>a : Cut, Fray d : Loose, Deformed k : Animal Hair s : Smell t : Cigarette Burns x : Defective y : Stain</p>

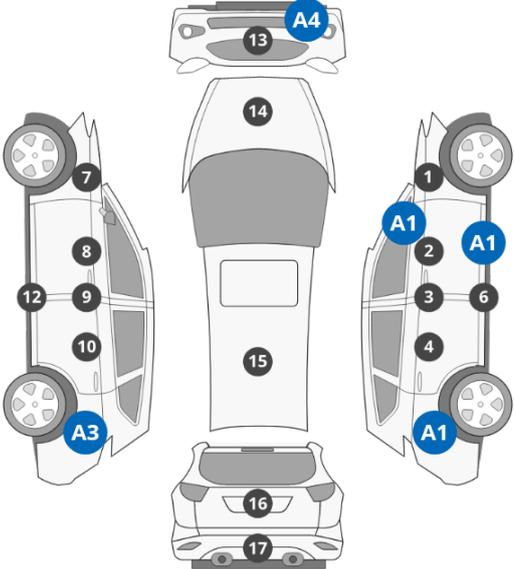
<p>A : Scratch AU : Scratch & Dent B : Modified C : Corrosion G : Stone chip P : Faded S : Rust SC : Rust & Corrosion U : Dent X : Defective Y : Crack, Gap</p>
<p>Remarks Rear Seat - Grime - Small / (R) Front Seat - Grime - Minimal</p>	<p>Remarks (L) Rear Fender, Molding - Scratch - Medium / (R) Rear Fender, Molding - Scratch - Minimal / (R) Mirror - Scratch - Minimal / Front Bumper, Grille, Lamps - Scratch - Large / (R) Step, In-panel, Side Spoiler - Scratch - Minimal</p>
Frame Evaluation : A	Functional Evaluation : A
<p>Remarks Defects not found</p>	<p>Remarks Defects not found</p>
