## General Information

<b>Make</b>	Toyota	<b>Model</b>	Vios
<b>YOM</b>	2018	<b>Odo Meter Reading</b>	52,051
<b>Registration No.</b>	A1W709	<b>Chassis No.</b>	PA1B19F39H4045698
<b>CC</b>	1.3	<b>Transmission</b>	M/T
<b>Fuel Type</b>	Gas	<b>Type of Body</b>	Sedan
<b>Colour</b>	Orange

## Body / Panel Condition

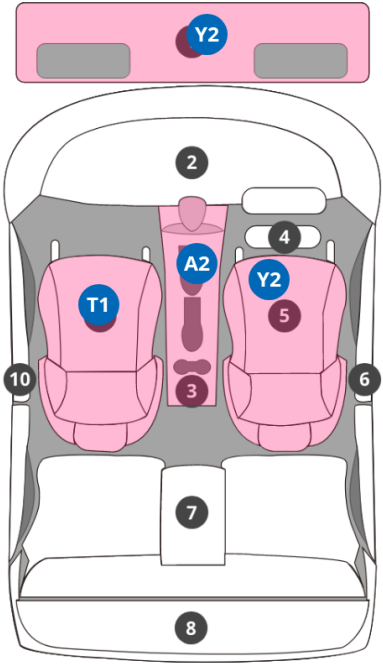
<b>Interior Evaluation :</b>	A	<b>Exterior Evaluation :</b>	N / A

<p><b>a</b> : Cut, Fray <b>d</b> : Loose, Deformed <b>k</b> : Animal Hair <b>s</b> : Smell <b>t</b> : Cigarette Burns <b>x</b> : Defective <b>y</b> : Stain</p>			
<p><b>Remarks</b> (R) Front Seat - Grime - Small / Ceiling - Grime - Small / Console, Switches, Vents - Worn, Scratch, Cut, Crack - Small / (L) Front Seat - Cigarette Burns - Burnt Minimal</p>		<p><b>Remarks</b> Defects not found</p>	
<b>Frame Evaluation :</b>	N / A	<b>Functional Evaluation :</b>	N / A
<p><b>Remarks</b> Defects not found</p>		<p><b>Remarks</b> Defects not found</p>
