## General Information

| Make | Toyota | Model | Wigo |

## Body / Panel Condition

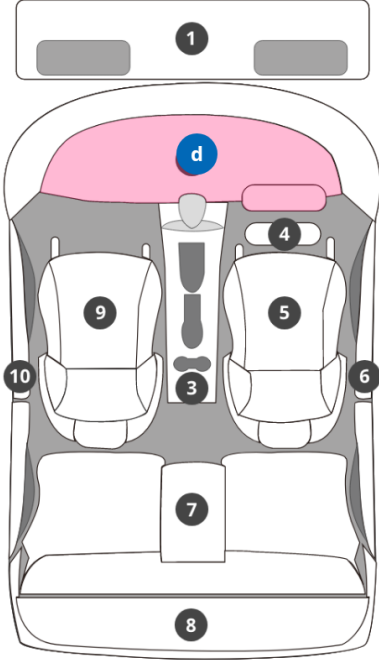
| Interior Evaluation : <span style="color: red;">A</span> | Exterior Evaluation : <span style="color: red;">D</span> |
| <b>Remarks</b><br>Dashboard - Traces of Adhesive Tape - Yes | <b>Remarks</b><br>(R) Mirror - Scratch - Minimal / (R) Step, In-panel, Side Spoiler - Scratch - Small / (R) Rear Door, Molding - Scratch - Minimal / (R) Front Wheel, Cover - Scratch, Corrosion - Small / (R) Front Tyre - Crack, Cut - Yes / (R) Rear Fender, Molding - Dent - Small / (L) Mirror - Scratch, Peeled - Minimal / (L) Rear Fender, Molding - Scratch - Medium / (L) Step, In-panel, Side Spoiler - Scratch & Dent - Medium / Front Bumper, Grille, Lamps - Crack, Gap - Large / Roof - Dent - Minimal / Rear Bumper, Lamps, Panels - Crack, Gap - Medium / Bonnet, Headlight - Scratch & Dent - Medium |
