## General Information

<b>Make</b>	Toyota	<b>Model</b>	Hilux
<b>YOM</b>	2022	<b>Odo Meter Reading</b>	51,422
<b>Registration No.</b>	NFG9407-1	<b>Chassis No.</b>	MR0JB8DD0M3186171
<b>CC</b>	2.4	<b>Transmission</b>	A/T
<b>Fuel Type</b>	Diesel	<b>Type of Body</b>	Pickup
<b>Colour</b>	Black

## Body / Panel Condition

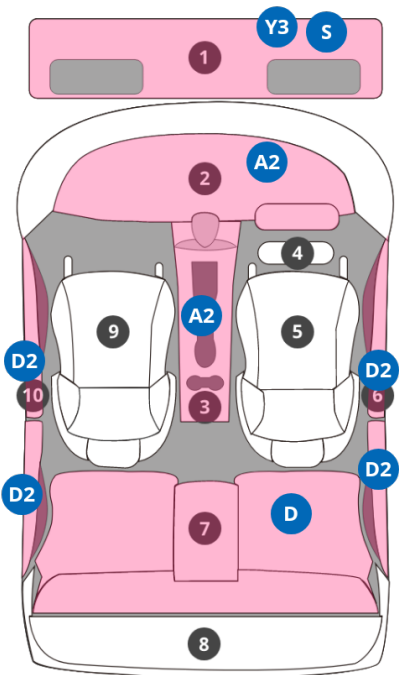
<b>Interior Evaluation :</b> <span style="float: right; color: red; font-weight: bold;">C</span>	<b>Exterior Evaluation :</b> <span style="float: right; color: red; font-weight: bold;">E</span>

<p><b>a</b> : Cut, Fray <b>d</b> : Loose, Deformed <b>k</b> : Animal Hair <b>s</b> : Smell <b>t</b> : Cigarette Burns <b>x</b> : Defective <b>y</b> : Stain</p>

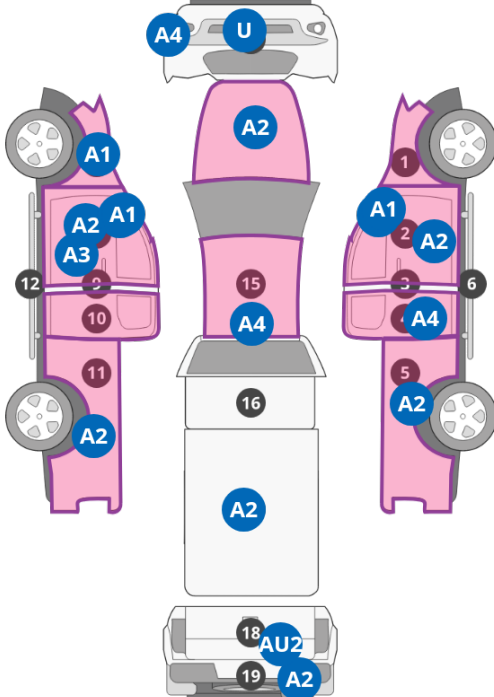
<p><b>A</b> : Scratch <b>AU</b> : Scratch &amp; Dent <b>B</b> : Modified <b>C</b> : Corrosion <b>G</b> : Stone chip <b>P</b> : Faded <b>S</b> : Rust <b>SC</b> : Rust &amp; Corrosion <b>U</b> : Dent <b>X</b> : Defective <b>Y</b> : Crack, Gap</p>
<p><b>Remarks</b> Ceiling - Grime - Medium / Console, Switchs, Vents - Worn, Scratch, Cut, Crack - Small / (L) Front Trim - Worked - Small / (R) Front Trim - Worked - Small / Overall Interior - Smell - Yes / Dashboard - Worn, Scratch, Cut, Crack - Small / (L) Rear Trim - Worked - Small / (R) Rear Trim - Worked - Small / Rear Seat - Worn - Yes</p>	<p><b>Remarks</b> (R) Front Door - Repair Traces - Yes / (R) Front Fender - Repair Traces - Yes / Bonnet - Repair Traces - Yes / (L) Front Fender - Repair Traces - Yes / (L) Rear Door - Repair Traces - Yes / (L) Rear Corner Panel - Repair Traces - Yes / (R) Rear Door - Repair Traces - Yes / Roof - Repair Traces - Yes / Rear Bumper, Lamps, Panels - Scratch - Small / Rear Gate - Scratch &amp; Dent - Small / (L) Side Gate - Scratch - Small / (L) Side Gate - Repair mark - Yes / (R) Side Gate - Repair mark - Yes / (L) Rear Door, Molding - Repair mark - Yes / (L) Front Door, Molding - Repair mark - Yes / (L) Front Fender, Molding - Repair mark - Yes / Bonnet, Headlight - Repair mark - Yes / (R) Front Fender, Molding - Repair mark - Yes / (R) Front Door, Molding - Repair mark - Yes / (R) Rear Door, Molding - Repair mark - Yes / Roof - Repair mark - Yes / Roof - Scratch - Large / (L) Rear Door, Molding - Scratch - Small / (L) Front Door, Molding - Scratch - Medium / (L) Front Fender, Molding - Scratch - Minimal / Bonnet, Headlight - Scratch - Small / Front Bumper, Grille, Lamps - Scratch - Large / Member (Bolted) - Dent - Yes / (R) Mirror - Faded(Color, Gloss) - Yes / (L) Mirror - Faded(Color, Gloss) - Yes / (R) Mirror - Scratch - Minimal / (L) Mirror - Scratch - Minimal / (R) Front Door, Molding - Scratch - Small / (R) Rear Door, Molding - Scratch - Large / (R) Side Gate - Scratch - Small / Cargo Bed Floor - Scratch - Small</p>
