General Information

Make	Toyota	Model	Vios
YOM	2024	Odo Meter Reading	29,112
Registration No.	NFR1390	Chassis No.	PA1B18F38R4245080
CC	1.3	Transmission	CVT
Fuel Type	Gas	Type of Body	Sedan
Colour	Silver

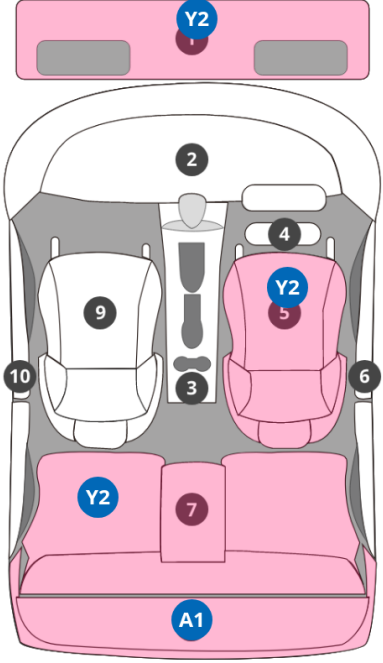
Interior Evaluation : A	Exterior Evaluation : C

<p>a : Cut, Fray d : Loose, Deformed k : Animal Hair s : Smell t : Cigarette Burns x : Defective y : Stain</p>

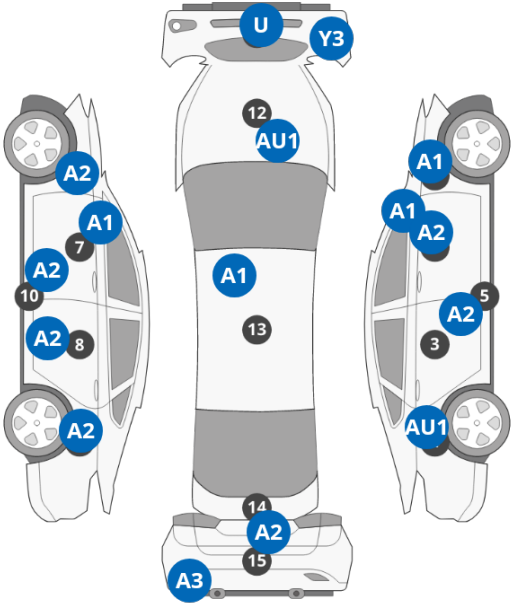
<p>A : Scratch AU : Scratch & Dent B : Modified C : Corrosion G : Stone chip P : Faded S : Rust SC : Rust & Corrosion U : Dent X : Defective Y : Crack, Gap</p>
<p>Remarks Trunk Room - Worn, Scratch, Cut, Crack - Minimal / Rear Seat - Grime - Small / (R) Front Seat - Grime - Small / Ceiling - Grime - Small</p>	<p>Remarks (R) Front Fender, Molding - Scratch - Minimal / (R) Mirror - Scratch - Minimal / (R) Front Door, Molding - Scratch - Small / (R) Rear Door, Molding - Scratch - Small / (R) Rear Fender, Molding - Scratch & Dent - Minimal / Rear Bumper, Lamps, Panels - Scratch - Medium / Trunk Hood, Rear Gate - Scratch - Small / (L) Rear Fender, Molding - Scratch - Small / (L) Rear Door, Molding - Scratch - Small / (L) Front Door, Molding - Scratch - Small / (L) Mirror - Scratch - Minimal / Roof - Scratch - Minimal / Member (Bolted) - Dent - Yes / Front Bumper, Grille, Lamps - Crack, Gap - Medium / Bonnet, Headlight - Scratch & Dent - Minimal / (L) Front Fender, Molding - Scratch - Small</p>
