General Information

Make	Toyota	Model	Lite Ace
YOM	2025	Odo Meter Reading	7,530
Registration No.	NHU3593	Chassis No.	MHKU3FE10RK008950
CC	1.5	Transmission	M/T
Fuel Type	Gas	Type of Body	Commercial Vehicles
Colour	White

Body / Panel Condition

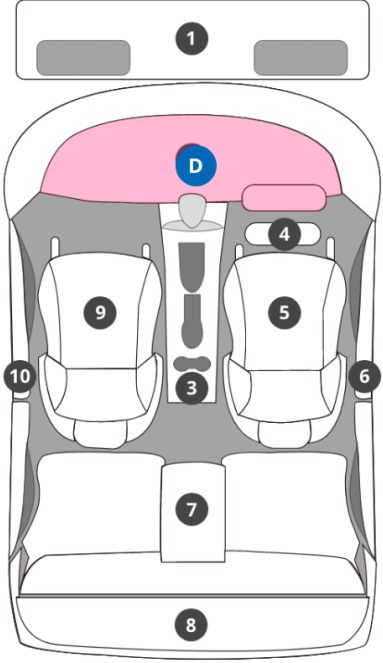
Interior Evaluation : A	Exterior Evaluation : E

<p>a : Cut, Fray d : Loose, Deformed k : Animal Hair s : Smell t : Cigarette Burns x : Defective y : Stain</p>

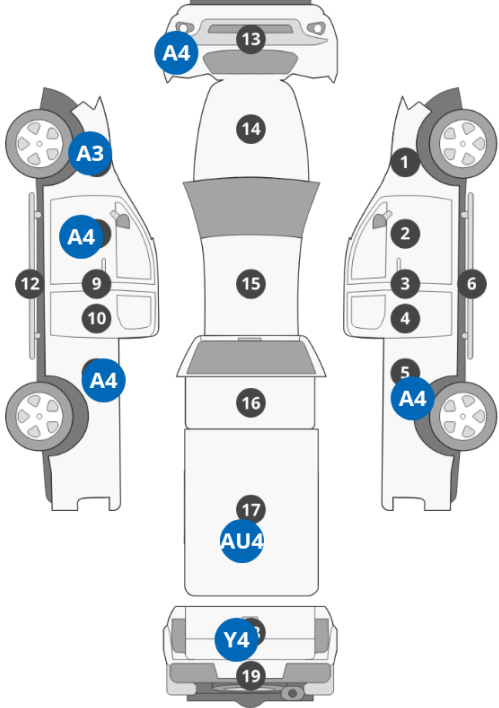
<p>A : Scratch AU : Scratch & Dent B : Modified C : Corrosion G : Stone chip P : Faded S : Rust SC : Rust & Corrosion U : Dent X : Defective Y : Crack, Gap</p>
Remarks Dashboard - Traces of Adhesive Tape - Yes	Remarks (L) Side Gate - Scratch - Large / (L) Front Door, Molding - Scratch - Large / (L) Front Fender, Molding - Scratch - Medium / Front Bumper, Grille, Lamps - Scratch - Large / (R) Side Gate - Scratch - Large / Rear Gate - Crack, Gap - Large / Cargo Bed Floor - Scratch & Dent - Large / Rear Bumper, Lamps, Panels - Scratch & Dent - Small
Frame Evaluation : A	Functional Evaluation : B
Remarks Defects not found	Remarks Battery - Weak - Yes / Reverse Camera - N/A - Yes / Spare Key - Issue - Unexist
