General Information

Make	Toyota	Model	Vios
YOM	2024	Odo Meter Reading	19,299
Registration No.	DBO5449	Chassis No.	PA1B18F37R4239125
CC	1.3	Transmission	CVT
Fuel Type	Gas	Type of Body	Sedan
Colour	Green

Body / Panel Condition

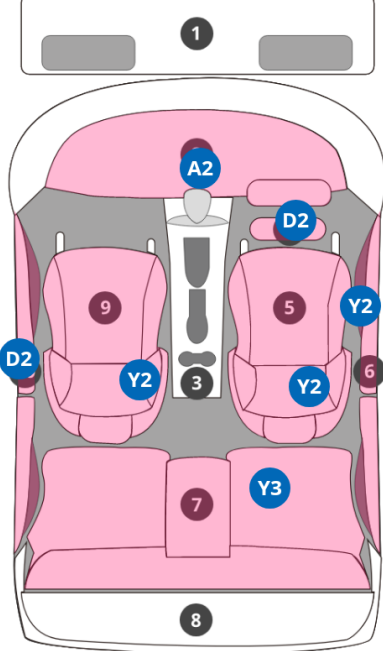
Interior Evaluation : B	Exterior Evaluation : B

<p>a : Cut, Fray d : Loose, Deformed k : Animal Hair s : Smell t : Cigarette Burns x : Defective y : Stain</p>

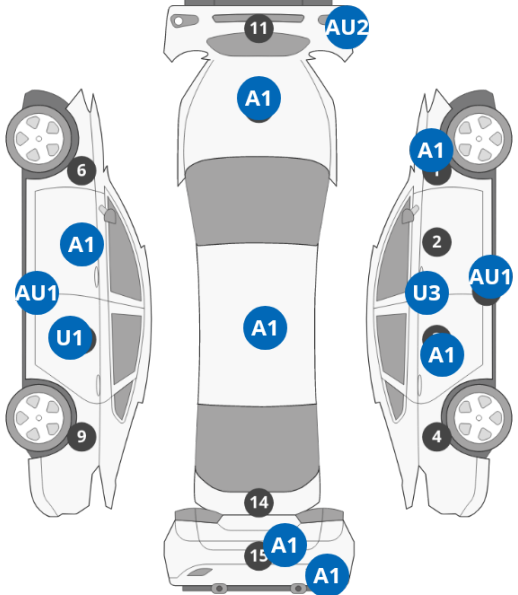
<p>A : Scratch AU : Scratch & Dent B : Modified C : Corrosion G : Stone chip P : Faded S : Rust SC : Rust & Corrosion U : Dent X : Defective Y : Crack, Gap</p>
<p>Remarks Rear Seat - Grime - Medium / (L) Front Seat - Grime - Small / (R) Front Seat - Grime - Small / Dashboard - Worn, Scratch, Cut, Crack - Small / (L) Front Floor Mat - Worked - Small / (R) Front Trim - Grime - Small / (L) Front Trim - Worked - Small</p>	<p>Remarks (L) Rear Door, Molding - Dent - Minimal / (L) Step, In-panel, Side Spoiler - Scratch & Dent - Minimal / Trunk Hood, Rear Gate - Scratch - Minimal / (R) Step, In-panel, Side Spoiler - Scratch & Dent - Minimal / (R) Rear Door, Molding - Scratch - Minimal / Rear Bumper, Lamps, Panels - Scratch - Minimal / Front Bumper, Grille, Lamps - Scratch & Dent - Small / Bonnet, Headlight - Scratch - Minimal / (L) Front Door, Molding - Scratch - Minimal / (R) Front Fender, Molding - Scratch - Minimal / Roof - Scratch - Minimal / (R) Front Door, Molding - Dent - Medium</p>

<p>Inspector Notes</p>
<p>With LTO plate and Sparetire and Jack and Incomplete Tools, No warranty booklet and scratch headlight and tail light. mold on some parts seats and floor matting.</p>
