General Information

Make	Toyota	Model	Vios
YOM	2023	Odo Meter Reading	99,177
Registration No.	NIG7498	Chassis No.	PA1B18F35N4199105
CC	1.3	Transmission	CVT
Fuel Type	Gas	Type of Body	Sedan
Colour	Red

Body / Panel Condition

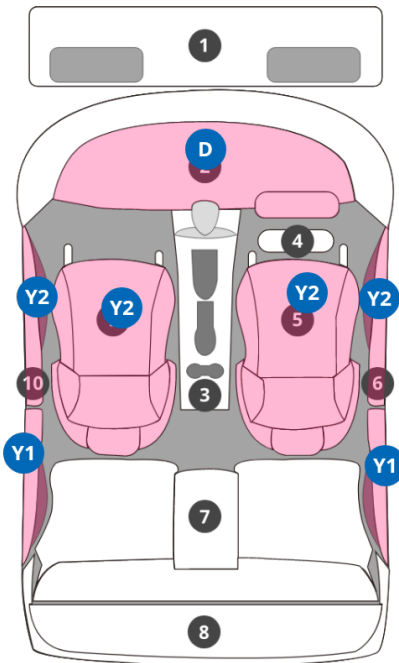
Interior Evaluation : B	Exterior Evaluation : C

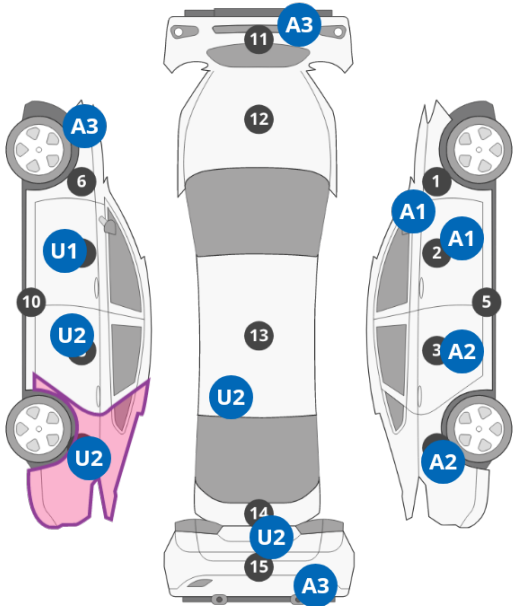
<p>A : Scratch AU : Scratch & Dent B : Modified C : Corrosion G : Stone chip P : Faded S : Rust SC : Rust & Corrosion U : Dent X : Defective Y : Crack, Gap</p>
<p>Remarks (R) Front Trim - Grime - Small / (R) Front Seat - Grime - Small / (R) Rear Trim - Grime - Minimal / (L) Rear Trim - Grime - Minimal / (L) Front Trim - Grime - Small / (L) Front Seat - Grime - Small / Dashboard - Traces of Adhesive Tape - Yes</p>	<p>Remarks (L) Rear Fender - Repair Traces - Yes / Trunk Hood, Rear Gate - Dent - Small / Rear Bumper, Lamps, Panels - Scratch - Medium / (R) Rear Fender, Molding - Scratch - Small / (L) Rear Fender, Molding - Repair mark - Yes / (R) Rear Door, Molding - Scratch - Small / (R) Mirror - Scratch - Minimal / (R) Front Door, Molding - Scratch - Minimal / Front Bumper, Grille, Lamps - Scratch - Medium / (L) Front Fender, Molding - Scratch - Medium / (L) Front Door, Molding - Dent - Minimal / (L) Rear Door, Molding - Dent - Small / (L) Rear Fender, Molding - Dent - Small / Roof - Dent - Small</p>
