General Information

Make	Toyota	Model	Vios
YOM	2024	Odo Meter Reading	50,669
Registration No.	NIQ5879	Chassis No.	PA1B18F31P4228540
CC	1.3	Transmission	CVT
Fuel Type	Gas	Type of Body	Sedan
Colour	Black

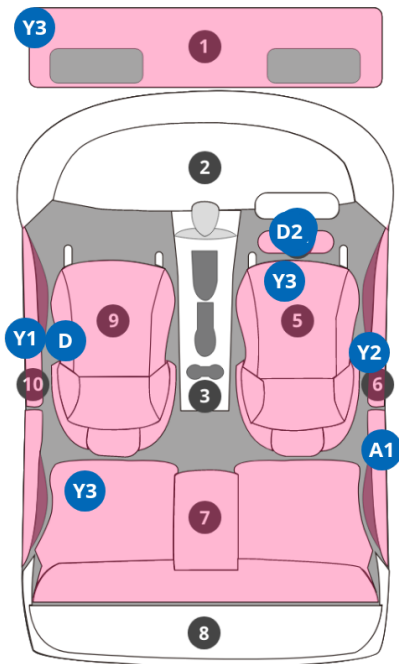
Interior Evaluation : C	Exterior Evaluation : E

<p>a : Cut, Fray d : Loose, Deformed k : Animal Hair s : Smell t : Cigarette Burns x : Defective y : Stain</p>

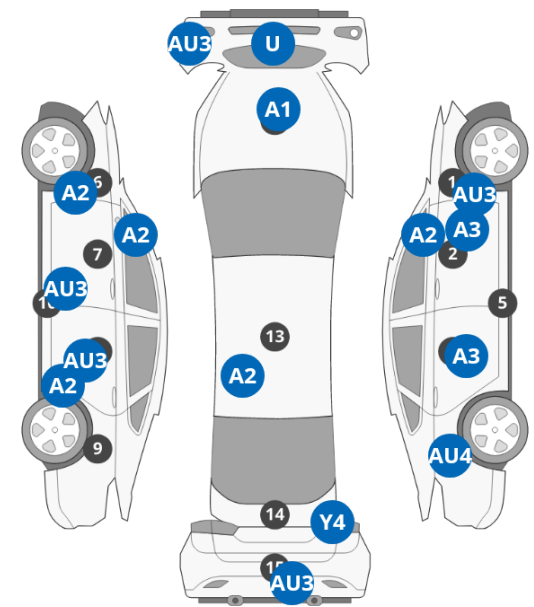
<p>A : Scratch AU : Scratch & Dent B : Modified C : Corrosion G : Stone chip P : Faded S : Rust SC : Rust & Corrosion U : Dent X : Defective Y : Crack, Gap</p>
<p>Remarks (R) Front Seat - Grime - Medium / Rear Seat - Grime - Medium / (R) Rear Trim - Cut, Crack - Minimal / Mat Other - Grime - Small / (R) Front Trim - Grime - Small / (L) Front Seat - Worn - Yes / (L) Front Floor Mat - Cut, Crack - Medium / Carpet - Worn, Scratch, Cut, Crack - Small / (L) Front Floor Mat - Worked - Small / Ceiling - Grime - Medium / (L) Front Trim - Grime - Minimal</p>	<p>Remarks (R) Front Fender, Molding - Scratch & Dent - Medium / (R) Front Door, Molding - Scratch - Medium / (R) Mirror - Scratch - Small / (R) Rear Door, Molding - Scratch - Medium / (R) Rear Fender, Molding - Scratch & Dent - Large / Rear Bumper, Lamps, Panels - Scratch & Dent - Medium / Trunk Hood, Rear Gate - Crack, Gap - Large / (L) Rear Fender, Molding - Scratch - Small / (L) Rear Door, Molding - Scratch & Dent - Medium / (L) Front Door, Molding - Scratch & Dent - Medium / (L) Mirror - Scratch - Small / Member (Bolted) - Dent - Yes / (L) Front Fender, Molding - Scratch - Small / Front Bumper, Grille, Lamps - Scratch & Dent - Medium / Bonnet, Headlight - Scratch - Minimal / Roof - Scratch - Small</p>
