## General Information

<b>Make</b>	Toyota	<b>Model</b>	Vios
<b>YOM</b>	2022	<b>Mileage</b>	22,468
<b>Registration No.</b>	NFJ7459	<b>Chassis No.</b>	PA1B18F34N4170596
<b>CC</b>	1.3	<b>Transmission</b>	CVT
<b>Fuel Type</b>	Gas	<b>Type of Body</b>	Sedan
<b>Colour</b>	Blue

## Body / Panel Condition

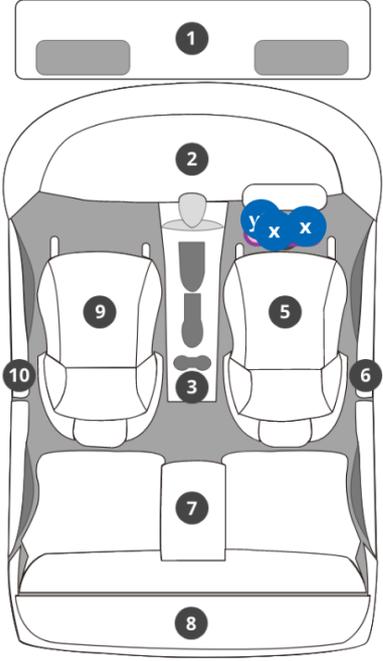
<b>Interior Evaluation :</b> <span style="float: right;"><b>B</b></span>	<b>Exterior Evaluation :</b> <span style="float: right;"><b>B</b></span>

<p><b>a</b> : Cut, Fray <b>d</b> : Loose, Deformed <b>k</b> : Animal Hair <b>s</b> : Smell <b>t</b> : Cigarette Burns <b>x</b> : Defective <b>y</b> : Stain</p>

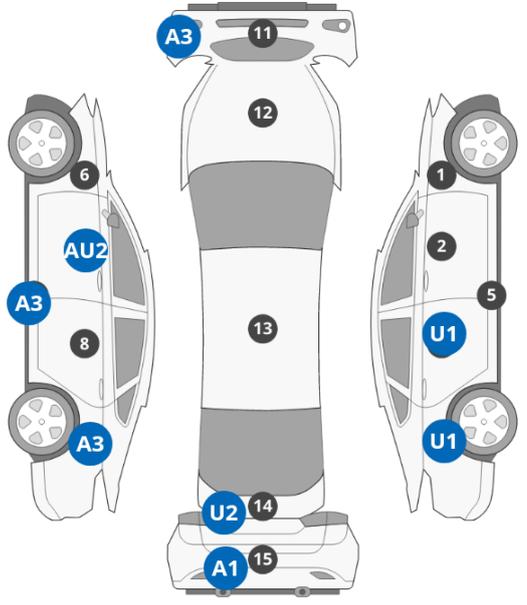
<p><b>A</b> : Scratch <b>AU</b> : Scratch &amp; Dent <b>B</b> : Modified <b>C</b> : Corrosion <b>G</b> : Stone chip <b>P</b> : Faded <b>S</b> : Rust <b>SC</b> : Rust &amp; Corrosion <b>U</b> : Dent <b>X</b> : Defective <b>Y</b> : Crack, Gap</p>
<p><b>Remarks</b> (R) Front Floor Mat - Missing - Yes / (L) Front Floor Mat - Grime - Small / Mat Other - Missing - Yes</p>	<p><b>Remarks</b> Bonnet - Repair Traces - Yes / (R) Rear Door, Molding - Dent - Minimal / (L) Front Door, Molding - Scratch &amp; Dent - Small / (R) Rear Fender, Molding - Dent - Minimal / (L) Rear Fender, Molding - Scratch - Medium / Front Bumper, Grille, Lamps - Scratch - Medium / (L) Step, In-panel, Side Spoiler - Scratch - Medium / Rear Bumper, Lamps, Panels - Scratch - Minimal / Trunk Hood, Rear Gate - Dent - Small</p>

<p><b>Inspector Notes</b></p>
<p>swirlmarks and hairline scratches around the exterior. with warranty booklet and user manual. no tools.</p>
