General Information

Make	Toyota	Model	Vios
YOM	2025	Odo Meter Reading	43,158
Registration No.	DBP2619	Chassis No.	PA1B18F33R4261929
CC	1.3	Transmission	CVT
Fuel Type	Gas	Type of Body	Sedan
Colour	Blue

Body / Panel Condition

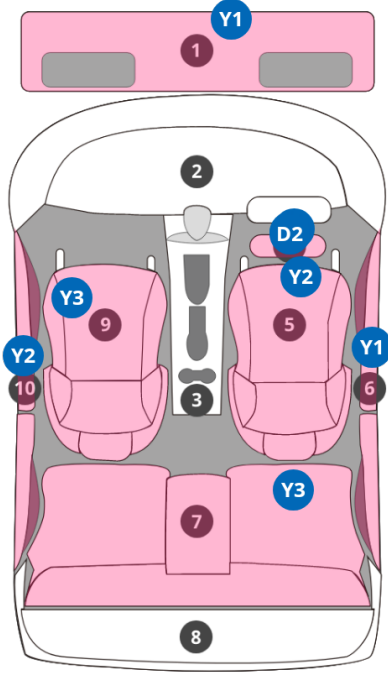
Interior Evaluation : C	Exterior Evaluation : D

<p>a : Cut, Fray d : Loose, Deformed k : Animal Hair s : Smell t : Cigarette Burns x : Defective y : Stain</p>

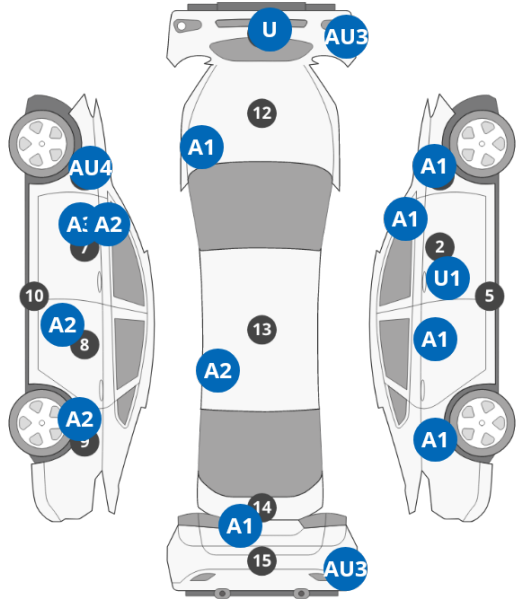
<p>A : Scratch AU : Scratch & Dent B : Modified C : Corrosion G : Stone chip P : Faded S : Rust SC : Rust & Corrosion U : Dent X : Defective Y : Crack, Gap</p>
<p>Remarks (L) Front Seat - Grime - Medium / (R) Front Seat - Grime - Small / Rear Seat - Grime - Medium / (R) Front Trim - Grime - Minimal / (R) Front Floor Mat - Grime - Small / (L) Front Trim - Grime - Small / (L) Front Floor Mat - Cut, Crack - Small / (L) Front Floor Mat - Worked - Small / Ceiling - Grime - Minimal</p>	<p>Remarks (R) Front Fender, Molding - Scratch - Minimal / (R) Mirror - Scratch - Minimal / (R) Front Door, Molding - Dent - Minimal / (R) Rear Door, Molding - Scratch - Minimal / (R) Rear Fender, Molding - Scratch - Minimal / Rear Bumper, Lamps, Panels - Scratch & Dent - Medium / Trunk Hood, Rear Gate - Scratch - Minimal / (L) Rear Fender, Molding - Scratch - Small / (L) Rear Door, Molding - Scratch - Small / (L) Front Door, Molding - Scratch - Medium / (L) Mirror - Scratch - Small / (L) Front Fender, Molding - Scratch & Dent - Large / Member (Bolted) - Dent - Yes / Front Bumper, Grille, Lamps - Scratch & Dent - Medium / Bonnet, Headlight - Scratch - Minimal / Roof - Scratch - Small</p>

<p>Inspector Notes</p>
<p>no warranty booklet, with jack and tools, with spare tire, with LTO plate, scratched and cracked tail light, plate light issue</p>
