General Information

Make	Toyota	Model	Wigo
YOM	2025	Odo Meter Reading	7,459
Registration No.	DBQ7516	Chassis No.	MHKAA1BC6RJ027327
CC	1.0	Transmission	CVT
Fuel Type	Gas	Type of Body	Hatchback
Colour	Red

Body / Panel Condition

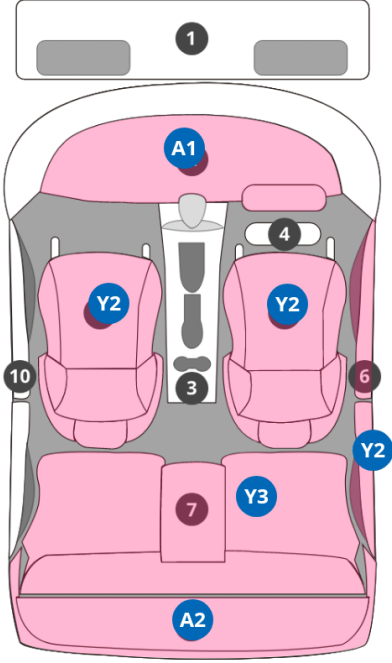
Interior Evaluation : B	Exterior Evaluation : D

<p>a : Cut, Fray d : Loose, Deformed k : Animal Hair s : Smell t : Cigarette Burns x : Defective y : Stain</p>

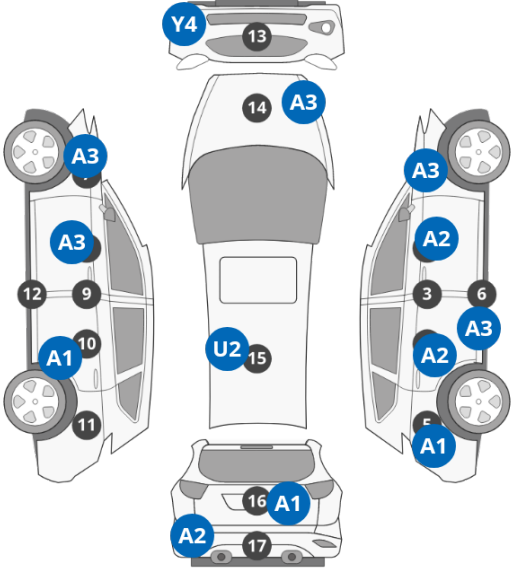
<p>A : Scratch AU : Scratch & Dent B : Modified C : Corrosion G : Stone chip P : Faded S : Rust SC : Rust & Corrosion U : Dent X : Defective Y : Crack, Gap</p>
Remarks (R) Front Seat - Grime - Small / Rear Seat - Grime - Medium / (R) Rear Trim - Grime - Small / Trunk Room - Worn, Scratch, Cut, Crack - Small / (L) Front Seat - Grime - Small / Dashboard - Worn, Scratch, Cut, Crack - Minimal	Remarks (L) Front Door, Molding - Scratch - Medium / (L) Front Fender, Molding - Scratch - Medium / Front Bumper, Grille, Lamps - Crack, Gap - Large / Bonnet, Headlight - Scratch - Medium / (R) Front Fender, Molding - Scratch - Medium / (R) Front Door, Molding - Scratch - Small / (R) Step, In-panel, Side Spoiler - Scratch - Medium / (R) Rear Door, Molding - Scratch - Small / (R) Rear Fender, Molding - Scratch - Minimal / Rear Bumper, Lamps, Panels - Scratch - Small / Trunk Hood, Rear Gate - Scratch - Minimal / (L) Rear Door, Molding - Scratch - Minimal / Roof - Dent - Small

Inspector Notes
with LTO plate/with spare tire/with jack/No tools/with reverse camera/No spare key/with warranty booklet/ front left bumper damage
