General Information

Make	Toyota	Model	Vios
YOM	2024	Odo Meter Reading	51,232
Registration No.	NFR6073	Chassis No.	PA1B18F3XR4255268
CC	1.3	Transmission	CVT
Fuel Type	Gas	Type of Body	Sedan
Colour	Black

Body / Panel Condition

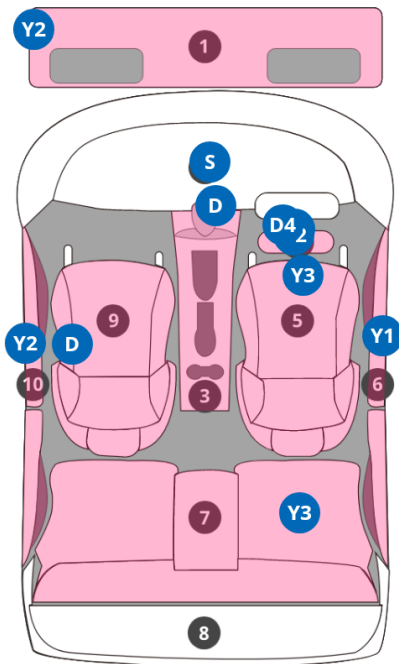
Interior Evaluation : C	Exterior Evaluation : D

<p>a : Cut, Fray d : Loose, Deformed k : Animal Hair s : Smell t : Cigarette Burns x : Defective y : Stain</p>

<p>A : Scratch AU : Scratch & Dent B : Modified C : Corrosion G : Stone chip P : Faded S : Rust SC : Rust & Corrosion U : Dent X : Defective Y : Crack, Gap</p>
<p>Remarks (R) Front Seat - Grime - Medium / (L) Front Seat - Worn - Yes / Rear Seat - Grime - Medium / (R) Front Trim - Grime - Minimal / Mat Other - Worked - Small / (R) Front Floor Mat - Worked - Small / (L) Front Floor Mat - Worked - Large / (L) Front Trim - Grime - Small / Console, Switchs, Vents - Traces of Adhesive Tape - Yes / Ceiling - Grime - Small / Overall Interior - Smell - Yes</p>	<p>Remarks (R) Front Fender, Molding - Scratch & Dent - Medium / (R) Mirror - Scratch - Small / (R) Front Door, Molding - Scratch & Dent - Medium / (R) Rear Door, Molding - Scratch - Small / (R) Rear Fender, Molding - Scratch - Small / Rear Bumper, Lamps, Panels - Scratch - Medium / Trunk Hood, Rear Gate - Dent - Small / (L) Rear Fender, Molding - Scratch - Small / (L) Rear Door, Molding - Scratch - Medium / (L) Front Door, Molding - Scratch - Small / (L) Mirror - Scratch - Small / Member (Bolted) - Dent - Yes / (L) Front Fender, Molding - Scratch - Minimal / Front Bumper, Grille, Lamps - Scratch - Medium / Bonnet, Headlight - Scratch - Minimal / Roof - Dent - Minimal</p>

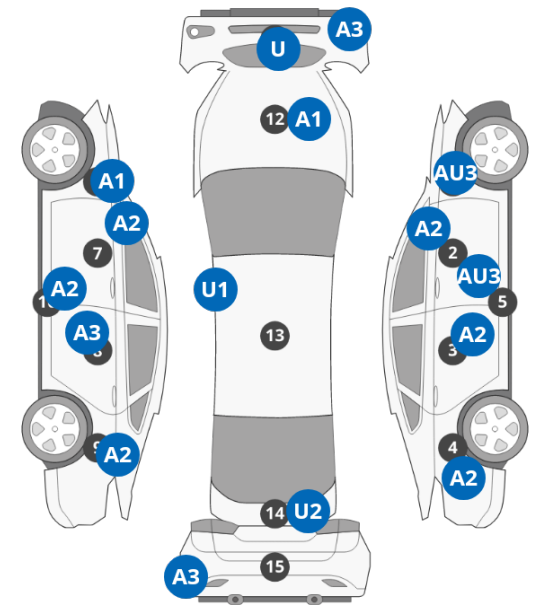
<p>Inspector Notes</p>
<p>with warranty booklet, with jack, incomplete tools, with spare tire, with LTO plate, scratches on tail light, trunk cover deformed</p>
