General Information

Make	Toyota	Model	Vios
YOM	2024	Odo Meter Reading	39,593
Registration No.	NIQ5566	Chassis No.	PA1B18F32P4228627
CC	1.3	Transmission	CVT
Fuel Type	Gas	Type of Body	Sedan
Colour	Black

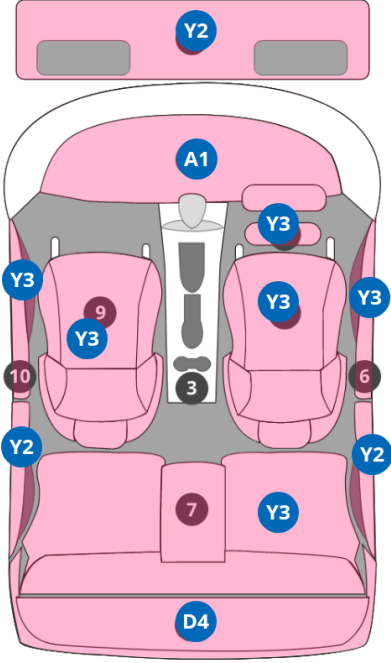
Interior Evaluation : D	Exterior Evaluation : E

<p>a : Cut, Fray d : Loose, Deformed k : Animal Hair s : Smell t : Cigarette Burns x : Defective y : Stain</p>

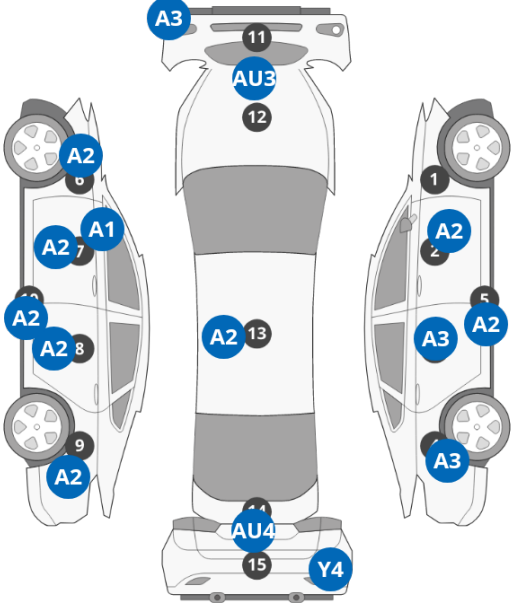
<p>A : Scratch AU : Scratch & Dent B : Modified C : Corrosion G : Stone chip P : Faded S : Rust SC : Rust & Corrosion U : Dent X : Defective Y : Crack, Gap</p>
Remarks (R) Front Trim - Grime - Medium / (R) Front Seat - Grime - Medium / Rear Seat - Grime - Medium / Trunk Room - Loose, Deformed - Large / (R) Rear Trim - Grime - Small / (L) Rear Trim - Grime - Small / (L) Front Trim - Grime - Medium / (L) Front Seat - Grime - Medium / (L) Front Floor Mat - Grime - Medium / Ceiling - Grime - Small / Dashboard - Worn, Scratch, Cut, Crack - Minimal	Remarks Rear Bumper, Lamps, Panels - Crack, Gap - Large / (R) Rear Fender, Molding - Scratch - Medium / (R) Rear Door, Molding - Scratch - Medium / (R) Step, In-panel, Side Spoiler - Scratch - Small / (R) Front Door, Molding - Scratch - Small / Front Bumper, Grille, Lamps - Scratch - Medium / (L) Front Fender, Molding - Scratch - Small / Bonnet, Headlight - Scratch & Dent - Medium / (L) Mirror - Scratch - Minimal / (L) Front Door, Molding - Scratch - Small / (L) Rear Door, Molding - Scratch - Small / (L) Rear Fender, Molding - Scratch - Small / Trunk Hood, Rear Gate - Scratch & Dent - Large / Roof - Scratch - Small / (L) Step, In-panel, Side Spoiler - Scratch - Small
