General Information

Make	Toyota	Model	Vios
YOM	2021	Odo Meter Reading	116,268
Registration No.	DAY1625	Chassis No.	PA1B18F32L4129199
CC	1.3	Transmission	CVT
Fuel Type	Gas	Type of Body	Sedan
Colour	Black

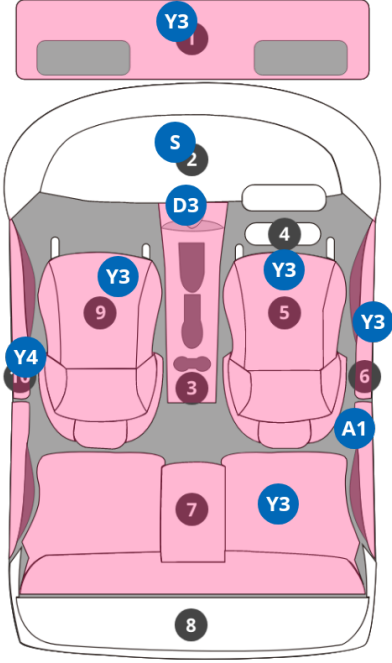
Interior Evaluation : D	Exterior Evaluation : E

<p>a : Cut, Fray d : Loose, Deformed k : Animal Hair s : Smell t : Cigarette Burns x : Defective y : Stain</p>

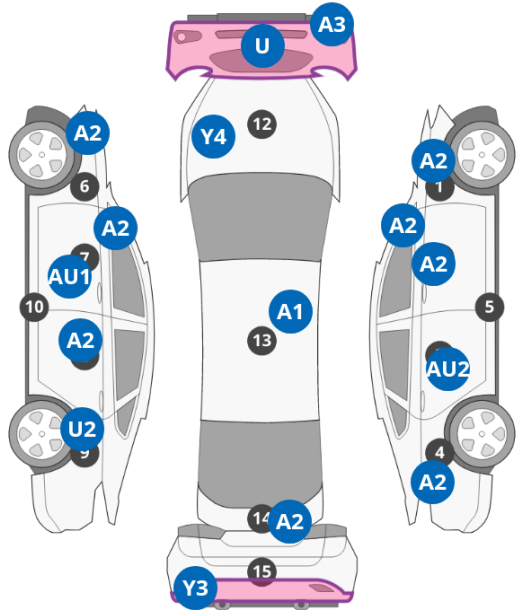
<p>A : Scratch AU : Scratch & Dent B : Modified C : Corrosion G : Stone chip P : Faded S : Rust SC : Rust & Corrosion U : Dent X : Defective Y : Crack, Gap</p>
<p>Remarks (R) Front Seat - Grime - Medium / (L) Front Seat - Grime - Medium / Rear Seat - Grime - Medium / Overall Interior - Smell - Yes / Overall Interior - Worn as per age - Yes / (R) Rear Trim - Cut, Crack - Minimal / (R) Front Trim - Grime - Medium / (L) Front Trim - Grime - Large / Console, Switches, Vents - Loose, Deformed - Medium / Ceiling - Grime - Medium</p>	<p>Remarks (R) Front Fender - Repair Traces - Yes / Bonnet - Repair Traces - Yes / (L) Front Fender - Repair Traces - Yes / (L) Front Door - Repair Traces - Yes / (L) Rear Fender - Repair Traces - Yes / (R) Rear Fender - Repair Traces - Yes / (R) Rear Door - Repair Traces - Yes / Roof - Repair Traces - Yes / (R) Front Fender, Molding - Scratch - Small / (R) Mirror - Scratch - Small / (R) Front Door, Molding - Scratch - Small / (R) Rear Door, Molding - Scratch & Dent - Small / (R) Rear Fender, Molding - Scratch - Small / Rear Bumper, Lamps, Panels - Repair mark - Yes / Overall Exterior - Faded(Color, Gloss) - Yes / Rear Bumper, Lamps, Panels - Crack, Gap - Medium / Trunk Hood, Rear Gate - Scratch - Small / (L) Rear Fender, Molding - Dent - Small / (L) Rear Door, Molding - Scratch - Small / (L) Front Door, Molding - Scratch & Dent - Minimal / Bonnet, Headlight - Crack, Gap - Large / (L) Mirror - Scratch - Small / (L) Front Fender, Molding - Scratch - Small / Member (Bolted) - Dent - Yes / Front Bumper, Grille, Lamps - Repair mark - Yes / Front Bumper, Grille, Lamps - Scratch - Medium / Roof - Scratch - Minimal</p>
