General Information

Make	Toyota	Model	Vios
YOM	2024	Odo Meter Reading	26,044
Registration No.	JAQ1730	Chassis No.	PA1B18F34P4227916
CC	1.3	Transmission	CVT
Fuel Type	Gas	Type of Body	Sedan
Colour	Blue

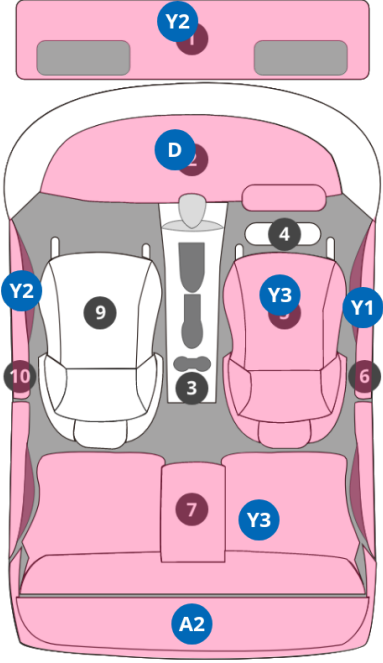
Interior Evaluation : B	Exterior Evaluation : C

<p>a : Cut, Fray d : Loose, Deformed k : Animal Hair s : Smell t : Cigarette Burns x : Defective y : Stain</p>

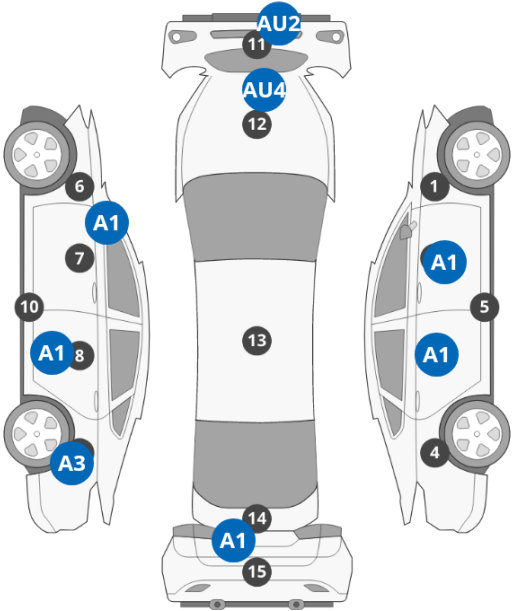
<p>A : Scratch AU : Scratch & Dent B : Modified C : Corrosion G : Stone chip P : Faded S : Rust SC : Rust & Corrosion U : Dent X : Defective Y : Crack, Gap</p>
Remarks (R) Front Trim - Grime - Minimal / (R) Front Seat - Grime - Medium / Rear Seat - Grime - Medium / Trunk Room - Worn, Scratch, Cut, Crack - Small / (L) Front Trim - Grime - Small / Dashboard - Traces of Adhesive Tape - Yes / Ceiling - Grime - Small	Remarks (R) Front Door, Molding - Scratch - Minimal / (R) Rear Door, Molding - Scratch - Minimal / Trunk Hood, Rear Gate - Scratch - Minimal / (L) Rear Fender, Molding - Scratch - Medium / (L) Rear Door, Molding - Scratch - Minimal / Bonnet, Headlight - Scratch & Dent - Large / Front Bumper, Grille, Lamps - Scratch & Dent - Small / (L) Mirror - Scratch - Minimal
