General Information

Make	Toyota	Model	Vios
YOM	2024	Odo Meter Reading	48,696
Registration No.	NFR6580	Chassis No.	PA1B18F36R4253341
CC	1.3	Transmission	CVT
Fuel Type	Gas	Type of Body	Sedan
Colour	Black

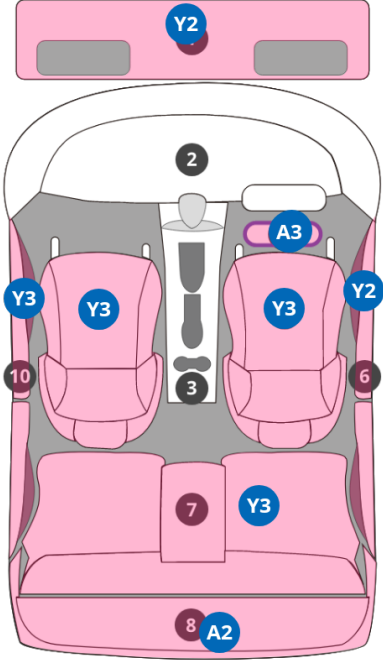
Interior Evaluation : C	Exterior Evaluation : C

<p>a : Cut, Fray d : Loose, Deformed k : Animal Hair s : Smell t : Cigarette Burns x : Defective y : Stain</p>

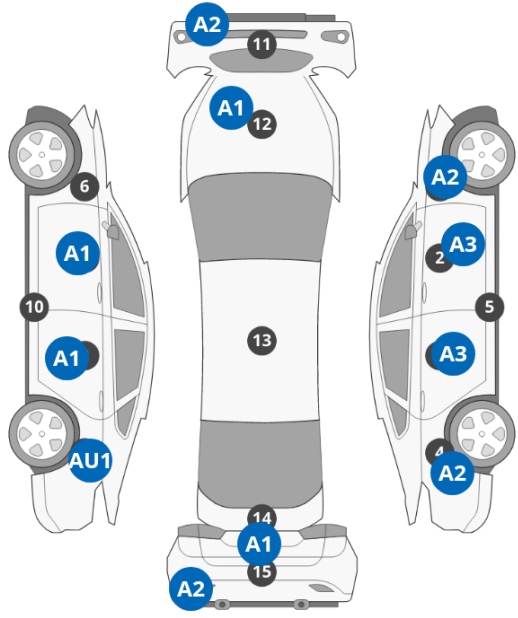
<p>A : Scratch AU : Scratch & Dent B : Modified C : Corrosion G : Stone chip P : Faded S : Rust SC : Rust & Corrosion U : Dent X : Defective Y : Crack, Gap</p>
<p>Remarks (R) Front Trim - Grime - Small / (R) Front Seat - Grime - Medium / (R) Front Floor Mat - Missing - Yes / Rear Seat - Grime - Medium / (L) Front Seat - Grime - Medium / (L) Front Trim - Grime - Medium / Trunk Room - Worn, Scratch, Cut, Crack - Small / (L) Front Floor Mat - Cut, Crack - Medium / Ceiling - Grime - Small</p>	<p>Remarks Bonnet, Headlight - Scratch - Minimal / Front Bumper, Grille, Lamps - Scratch - Small / (L) Rear Fender, Molding - Scratch & Dent - Minimal / (L) Rear Door, Molding - Scratch - Minimal / (L) Front Door, Molding - Scratch - Minimal / Trunk Hood, Rear Gate - Scratch - Minimal / Rear Bumper, Lamps, Panels - Scratch - Small / (R) Rear Fender, Molding - Scratch - Small / (R) Rear Door, Molding - Scratch - Medium / (R) Front Door, Molding - Scratch - Medium / (R) Front Fender, Molding - Scratch - Small</p>
