General Information

Make	Toyota	Model	Vios
YOM	2024	Odo Meter Reading	42,779
Registration No.	NHS2951	Chassis No.	PA1B18F39R4258646
CC	1.3	Transmission	CVT
Fuel Type	Gas	Type of Body	Sedan
Colour	Blue

Body / Panel Condition

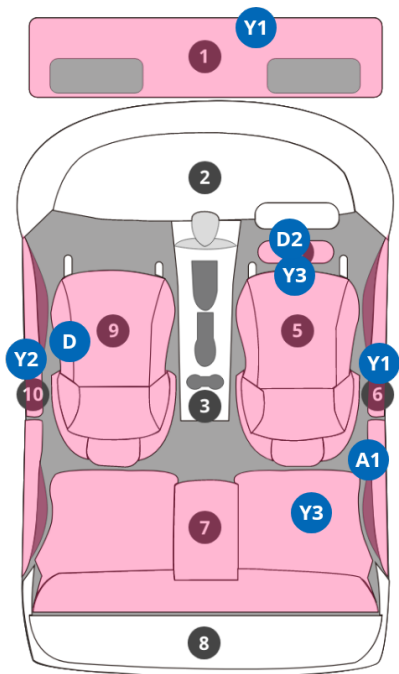
Interior Evaluation : B	Exterior Evaluation : D

<p>a : Cut, Fray d : Loose, Deformed k : Animal Hair s : Smell t : Cigarette Burns x : Defective y : Stain</p>

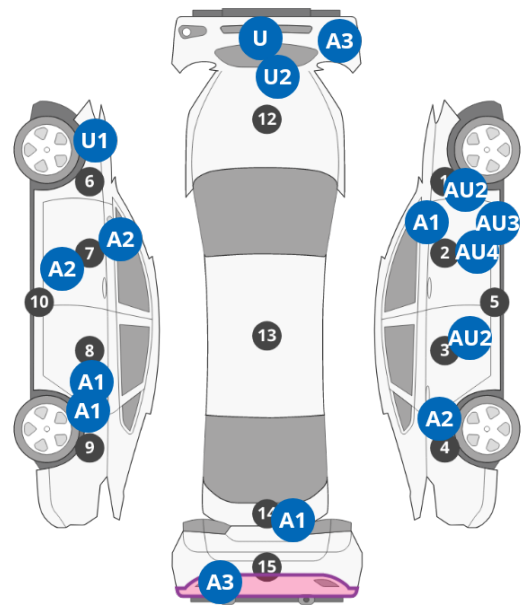
<p>A : Scratch AU : Scratch & Dent B : Modified C : Corrosion G : Stone chip P : Faded S : Rust SC : Rust & Corrosion U : Dent X : Defective Y : Crack, Gap</p>
<p>Remarks Rear Seat - Grime - Medium / (R) Rear Trim - Cut, Crack - Minimal / (R) Front Trim - Grime - Minimal / (R) Front Seat - Grime - Medium / (L) Front Seat - Worn - Yes / (L) Front Trim - Grime - Small / (L) Front Floor Mat - Worked - Small / Ceiling - Grime - Minimal</p>	<p>Remarks (R) Front Fender, Molding - Scratch & Dent - Small / (R) Mirror - Scratch - Minimal / (R) Front Door, Molding - Scratch & Dent - Large / (R) Rear Door, Molding - Scratch & Dent - Small / (R) Step, In-panel, Side Spoiler - Scratch & Dent - Medium / (R) Rear Fender, Molding - Scratch - Small / Rear Bumper, Lamps, Panels - Repair mark - Yes / Rear Bumper, Lamps, Panels - Scratch - Medium / Trunk Hood, Rear Gate - Scratch - Minimal / (L) Rear Fender, Molding - Scratch - Minimal / (L) Front Door, Molding - Scratch - Small / (L) Rear Door, Molding - Scratch - Minimal / (L) Mirror - Scratch - Small / Member (Bolted) - Dent - Yes / (L) Front Fender, Molding - Dent - Minimal / Front Bumper, Grille, Lamps - Scratch - Medium / Bonnet, Headlight - Dent - Small</p>
