## General Information

<b>Make</b>	Toyota	<b>Model</b>	Innova
<b>YOM</b>	2024	<b>Mileage</b>	17,286
<b>Registration No.</b>	DBM4909	<b>Chassis No.</b>	PA2JA8EM5R0138285
<b>CC</b>	2.8	<b>Transmission</b>	A/T
<b>Fuel Type</b>	Diesel	<b>Type of Body</b>	MPV
<b>Colour</b>	Silver

## Body / Panel Condition

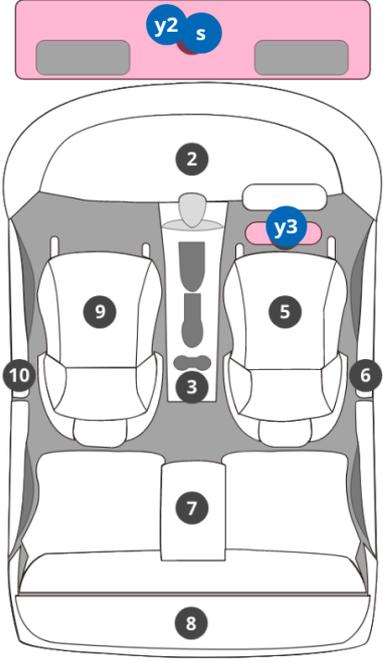
<b>Interior Evaluation :</b> <span style="float: right;"><b>B</b></span>	<b>Exterior Evaluation :</b> <span style="float: right;"><b>B</b></span>

<p><b>A</b> : Scratch <b>AU</b> : Scratch &amp; Dent <b>B</b> : Modified <b>C</b> : Corrosion <b>G</b> : Stone chip <b>P</b> : Faded <b>S</b> : Rust <b>SC</b> : Rust &amp; Corrosion <b>U</b> : Dent <b>X</b> : Defective <b>Y</b> : Crack, Gap</p>
<p><b>Remarks</b> Overall Interior - Smell - Yes / Mat Other - Grime - Medium / Ceiling - Grime - Small</p>	<p><b>Remarks</b> (R) Rear Fender, Molding - Scratch &amp; Dent - Small / (R) Rear Door, Molding - Scratch &amp; Dent - Small / Rear Bumper, Lamps, Panels - Scratch - Small / (L) Mirror - Scratch - Minimal / (R) Front Door, Molding - Scratch - Medium / Front Windshield - Scratch, Stone chip - Small</p>

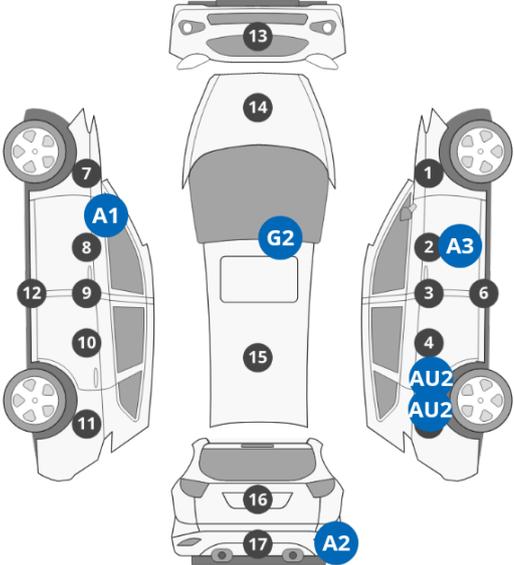
<p><b>Inspector Notes</b></p>
<p>swirlmarks and hairline scratches around the exterior. with tools,warranty booklet and user manual.</p>
