General Information

Make	Toyota	Model	Vios
YOM	2023	Odo Meter Reading	50,834
Registration No.	DBJ6927	Chassis No.	PA1B18F33P4225431
CC	1.3	Transmission	CVT
Fuel Type	Gas	Type of Body	Sedan
Colour	Black

Body / Panel Condition

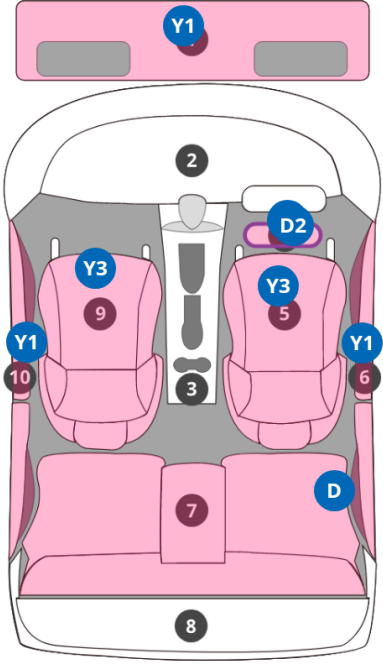
Interior Evaluation : B	Exterior Evaluation : D

<p>a : Cut, Fray d : Loose, Deformed k : Animal Hair s : Smell t : Cigarette Burns x : Defective y : Stain</p>

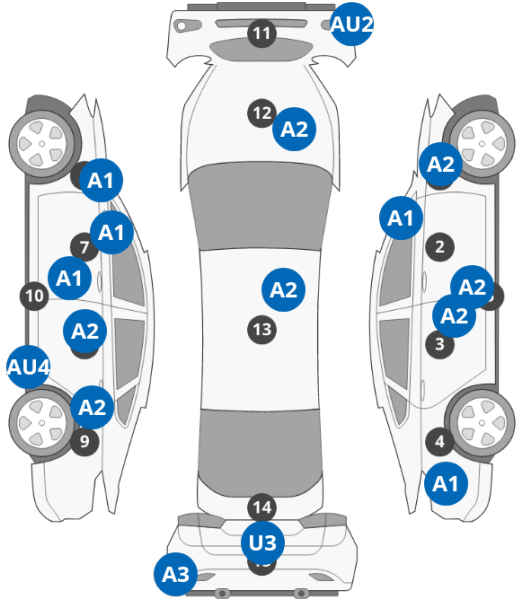
<p>A : Scratch AU : Scratch & Dent B : Modified C : Corrosion G : Stone chip P : Faded S : Rust SC : Rust & Corrosion U : Dent X : Defective Y : Crack, Gap</p>
<p>Remarks Mat Other - Missing - Yes / (L) Front Seat - Grime - Medium / (R) Front Seat - Grime - Medium / Rear Seat - Worn - Yes / (R) Front Trim - Grime - Minimal / (L) Front Floor Mat - Worked - Small / (L) Front Trim - Grime - Minimal / Ceiling - Grime - Minimal</p>	<p>Remarks (R) Front Fender, Molding - Scratch - Small / (R) Mirror - Scratch - Minimal / (R) Front Door, Molding - Scratch - Small / (R) Rear Door, Molding - Scratch - Small / (R) Rear Fender, Molding - Scratch - Minimal / Rear Bumper, Lamps, Panels - Scratch - Medium / Trunk Hood, Rear Gate - Dent - Medium / (L) Rear Fender, Molding - Scratch - Small / (L) Rear Door, Molding - Scratch - Small / (L) Mirror - Scratch - Minimal / (L) Step, In-panel, Side Spoiler - Scratch & Dent - Large / (L) Front Door, Molding - Scratch - Minimal / (L) Front Fender, Molding - Scratch - Minimal / Front Bumper, Grille, Lamps - Scratch & Dent - Small / Bonnet, Headlight - Scratch - Small / Roof - Scratch - Small</p>
