General Information

Make	Toyota	Model	Vios
YOM	2024	Odo Meter Reading	20,871
Registration No.	DBP1955	Chassis No.	PA1B18F31R4258477
CC	1.3	Transmission	CVT
Fuel Type	Gas	Type of Body	Sedan
Colour	Silver

Body / Panel Condition

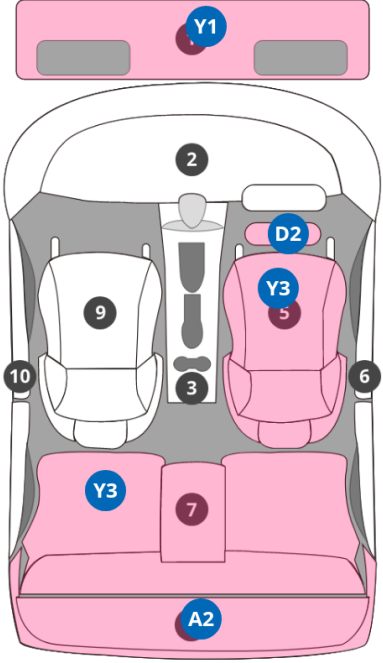
Interior Evaluation : B	Exterior Evaluation : D

<p>a : Cut, Fray d : Loose, Deformed k : Animal Hair s : Smell t : Cigarette Burns x : Defective y : Stain</p>

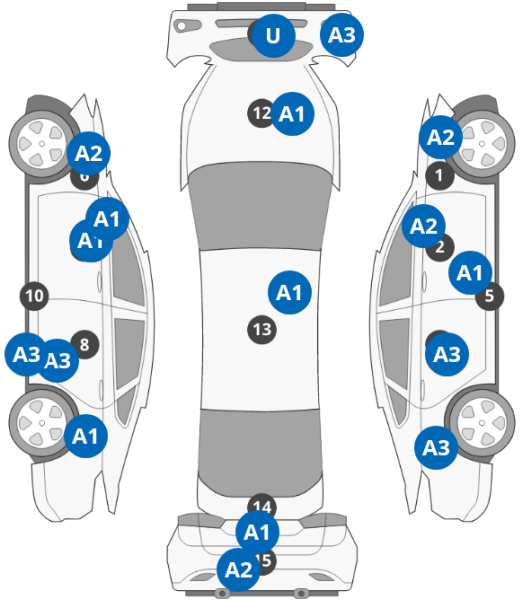
<p>A : Scratch AU : Scratch & Dent B : Modified C : Corrosion G : Stone chip P : Faded S : Rust SC : Rust & Corrosion U : Dent X : Defective Y : Crack, Gap</p>
<p>Remarks Trunk Room - Worn, Scratch, Cut, Crack - Small / Rear Seat - Grime - Medium / (L) Front Floor Mat - Worked - Small / Ceiling - Grime - Minimal / (R) Front Seat - Grime - Medium</p>	<p>Remarks (R) Step - Repair Traces - Yes / Member (Bolted) - Dent - Yes / (R) Front Fender, Molding - Scratch - Small / (R) Mirror - Scratch - Small / (R) Front Door, Molding - Scratch - Minimal / (R) Rear Door, Molding - Scratch - Medium / (R) Rear Fender, Molding - Scratch - Medium / Rear Bumper, Lamps, Panels - Scratch - Small / Trunk Hood, Rear Gate - Scratch - Minimal / (L) Rear Fender, Molding - Scratch - Minimal / (L) Rear Door, Molding - Scratch - Medium / (L) Step, In-panel, Side Spoiler - Scratch - Medium / (L) Front Door, Molding - Scratch - Minimal / (L) Mirror - Scratch - Minimal / (L) Front Fender, Molding - Scratch - Small / Front Bumper, Grille, Lamps - Scratch - Medium / Roof - Scratch - Minimal / Bonnet, Headlight - Scratch - Minimal</p>
