General Information

Make	Toyota	Model	Wigo
YOM	2022	Odo Meter Reading	39,637
Registration No.	NFE8424	Chassis No.	MHKA4DF5FNJ072127
CC	1.0	Transmission	A/T
Fuel Type	Gas	Type of Body	Hatchback
Colour	Yellow

Body / Panel Condition

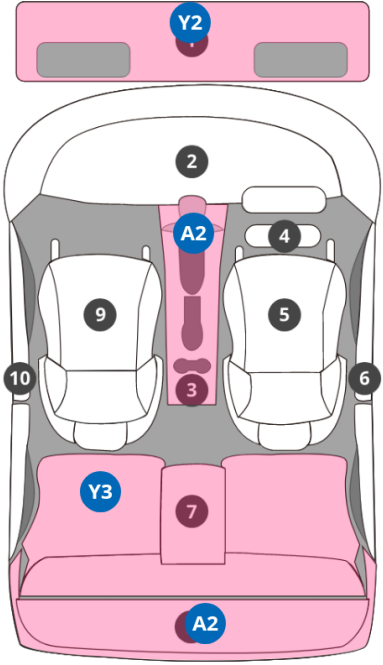
Interior Evaluation : B	Exterior Evaluation : D

<p>a : Cut, Fray d : Loose, Deformed k : Animal Hair s : Smell t : Cigarette Burns x : Defective y : Stain</p>

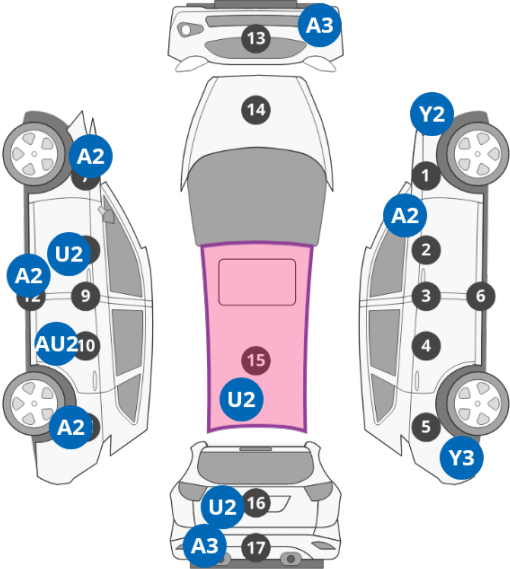
<p>A : Scratch AU : Scratch & Dent B : Modified C : Corrosion G : Stone chip P : Faded S : Rust SC : Rust & Corrosion U : Dent X : Defective Y : Crack, Gap</p>
<p>Remarks Ceiling - Grime - Small / Console, Switchs, Vents - Worn, Scratch, Cut, Crack - Small / Rear Seat - Grime - Medium / Trunk Room - Worn, Scratch, Cut, Crack - Small</p>	<p>Remarks Roof - Repair Traces - Yes / Rear Bumper, Lamps, Panels - Scratch - Medium / Trunk Hood, Rear Gate - Dent - Small / (R) Rear Fender, Molding - Crack, Gap - Medium / (R) Mirror - Scratch - Small / Front Bumper, Grille, Lamps - Scratch - Medium / (R) Front Fender, Molding - Crack, Gap - Small / (L) Front Fender, Molding - Scratch - Small / (L) Front Door, Molding - Dent - Small / (L) Step, In-panel, Side Spoiler - Scratch - Small / (L) Rear Door, Molding - Scratch & Dent - Small / (L) Rear Fender, Molding - Scratch - Small / Roof - Repair mark - Yes / Roof - Dent - Small</p>
